SK-CI001 - Block A HAZMAT Demolition Plan
 Revision A - 25 May 2025

HAZARDOUS MATERIALS RESURVEYS

PADSTOW TAFE CAMPUS
RAINE RD, PADSTOW NSW 2211

Hazardous Materials Resurveys
Padstow TAFE Campus
Raine Rd, Padstow NSW 2211

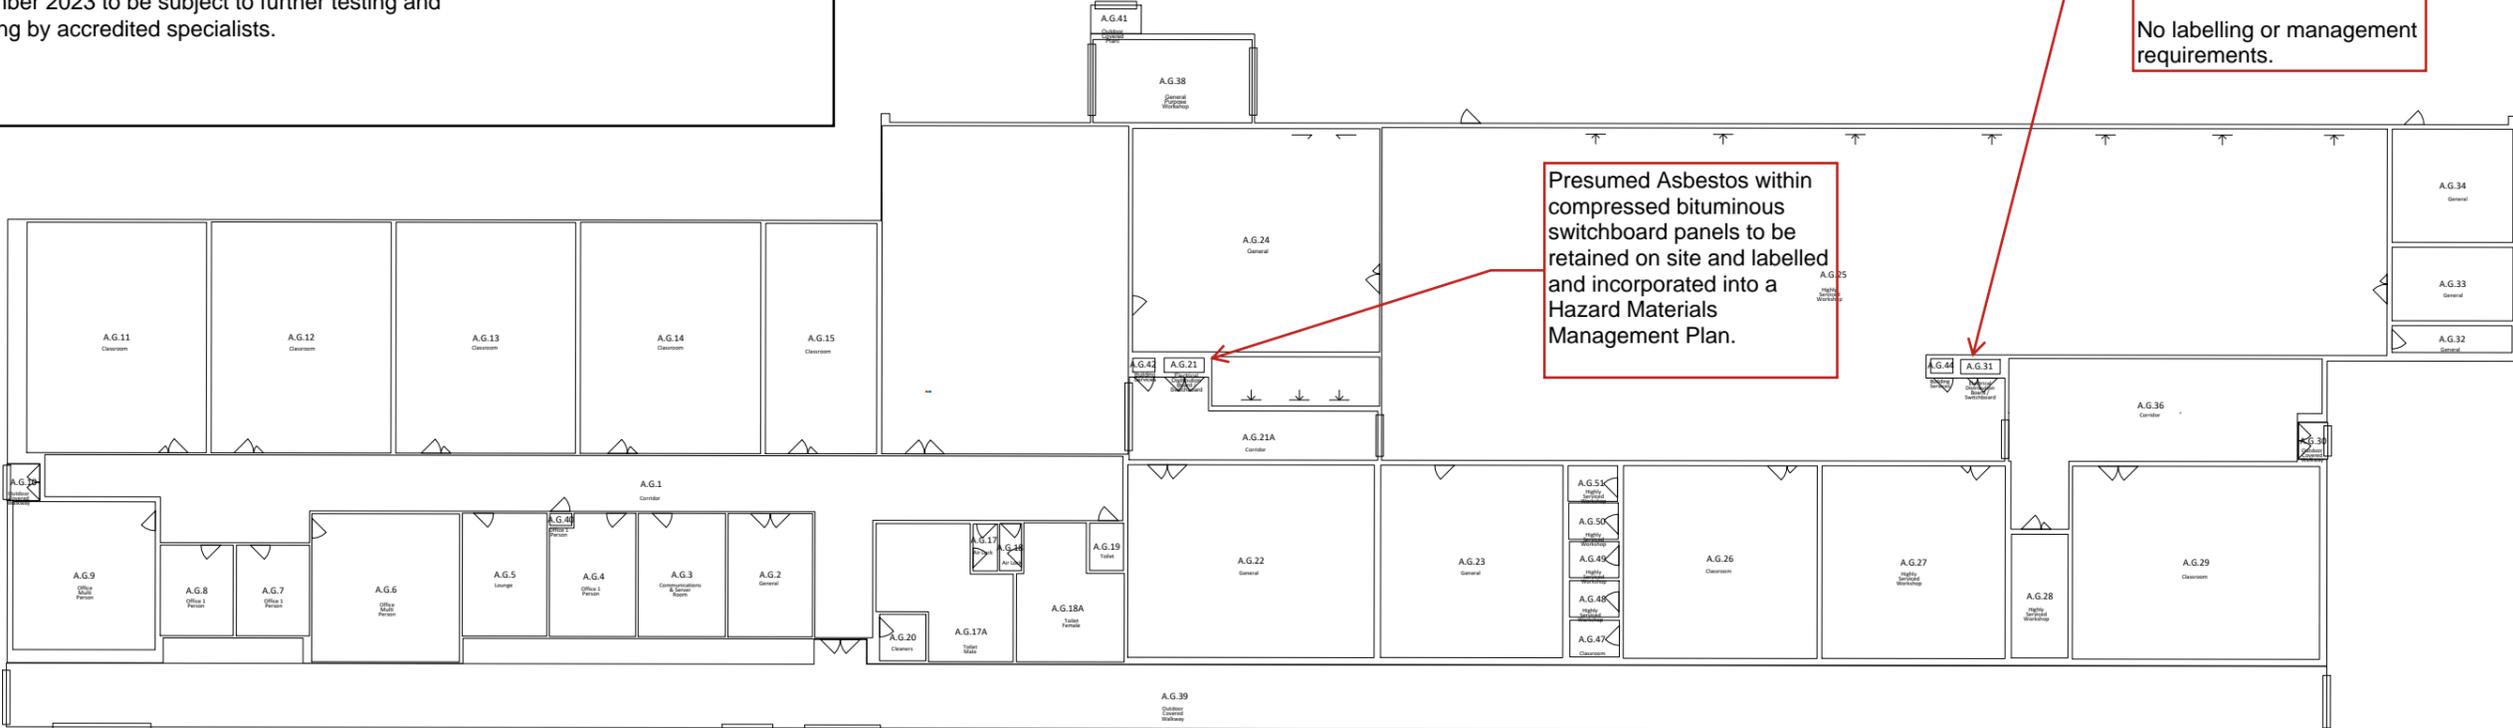
Actions for HAZMAT Detected Throughout SMF
 observed within hot water heater pipework insulation and ceiling tiles to be removed under controlled conditions prior to refurb.

ODS
 observed within existing AC units, o be removed under controlled conditions prior to refurb.

Presumed Asbestos within compressed bituminous switchboard panels referenced in HAZMAT survey was removed during install of new switchboard by TAFE in 2025.
 No labelling or management requirements.

Presumed Asbestos within compressed bituminous switchboard panels to be retained on site and labelled and incorporated into a Hazard Materials Management Plan.

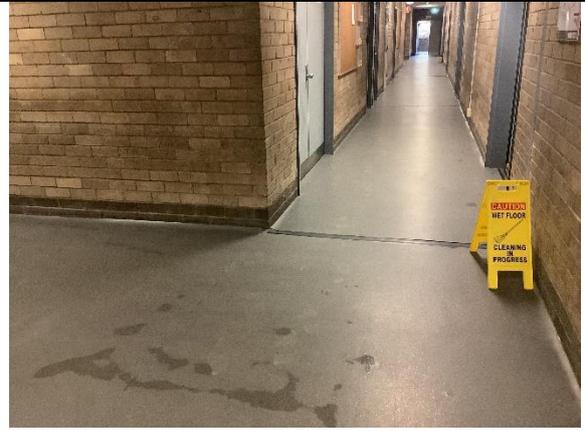
Photo 8: Building A – A.G.1 – Throughout – Floor – Floor Covering – Vinyl Sheet- Light Grey

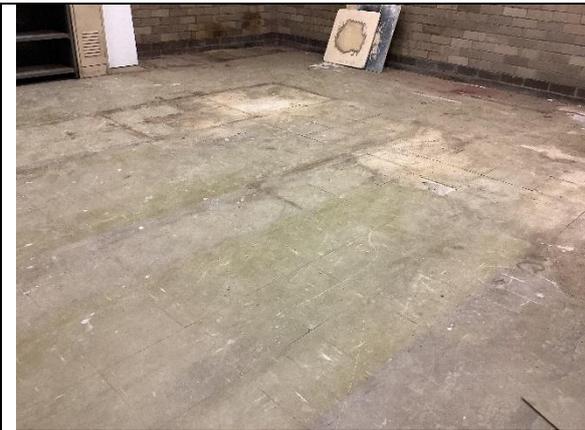
Photo 13: Building A – A.G.33 – Throughout – Floor Covering – Vinyl Tiles - Khaki

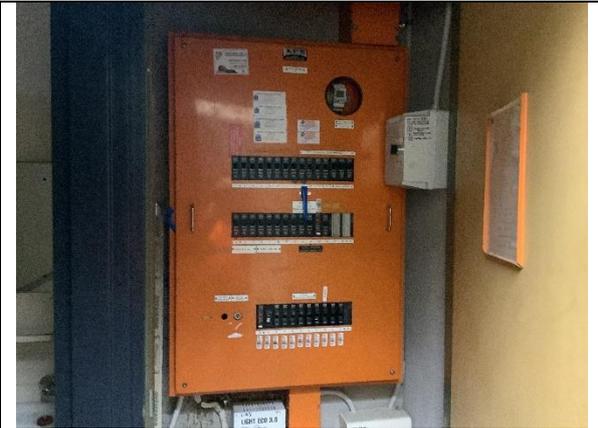
Photo 26: Building B – B.G.23 – Electrical Distribution Board – Compressed Bituminous Electrical Panel

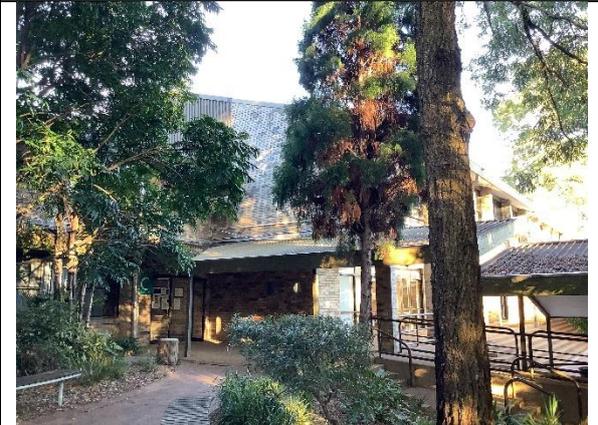
Photo 28: Building C

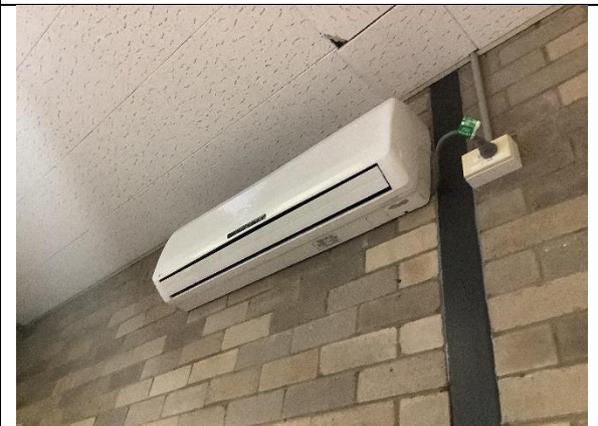
Photo 30: Building C – Throughout – A/C Units

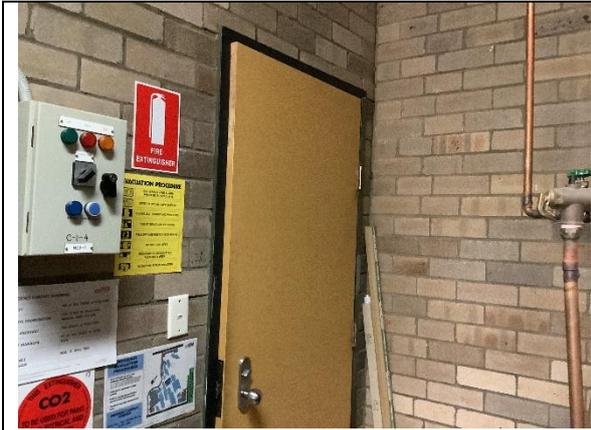
Photo 31: Building C – Throughout – Ductwork, Doors and Door Frames – Paint - Cream

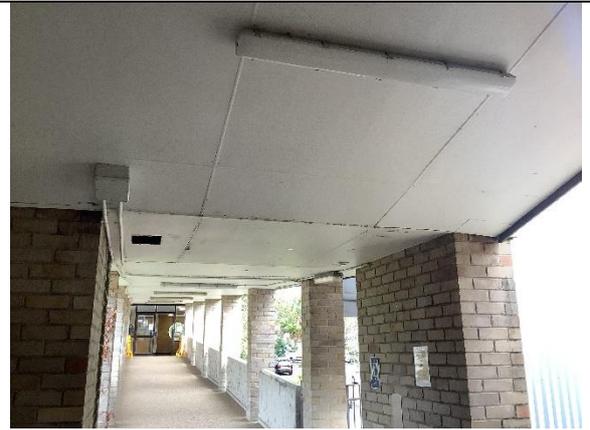
Photo 32: Building C – C.G.31 – Throughout – Awning – Fibre Cement Sheet

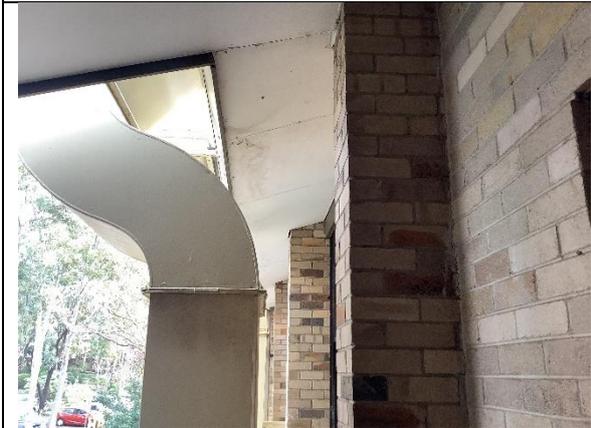
Photo 33: Building C – Various – Throughout – Awning – Fibre Cement Sheet

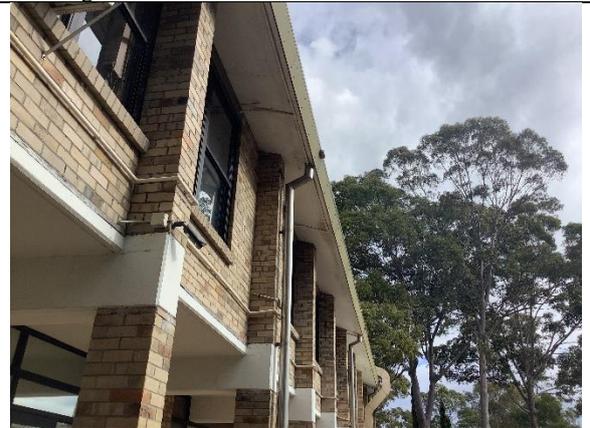
Photo 34: Building C – Throughout – Awning – Fibre Cement Sheet

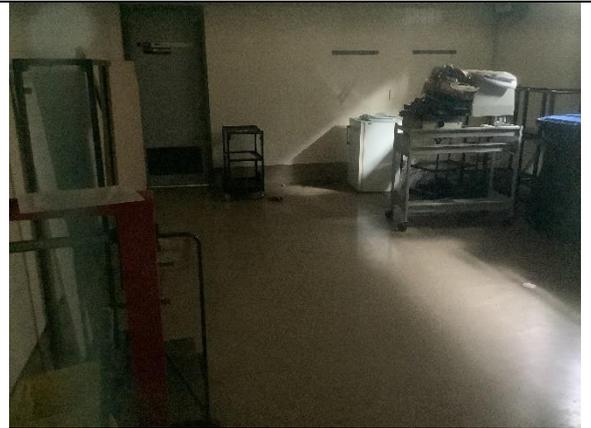
Photo 38: Building C – C.G.18 – Throughout – Floor Covering – Vinyl Sheet - Brown

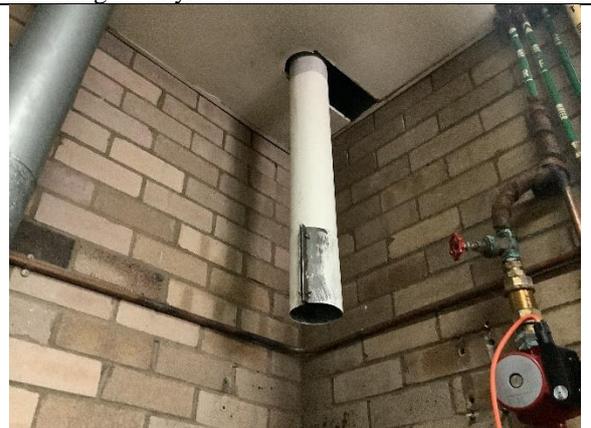
Photo 40: Building C – C.1.4 – North – Flue – Moulded Cement Flue

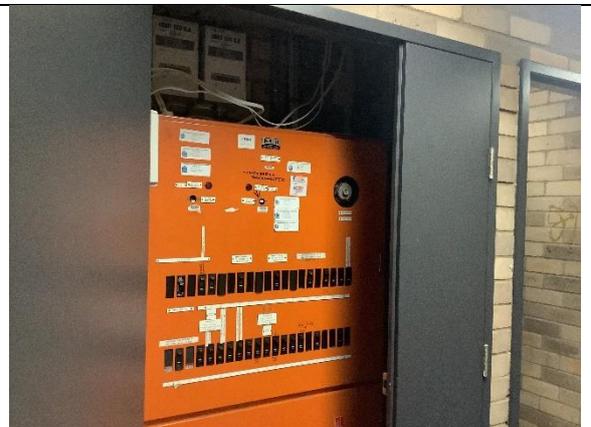
Photo 42: Building C – C.1.13 – Electrical Distribution Board – Compressed Bituminous Electrical Panel

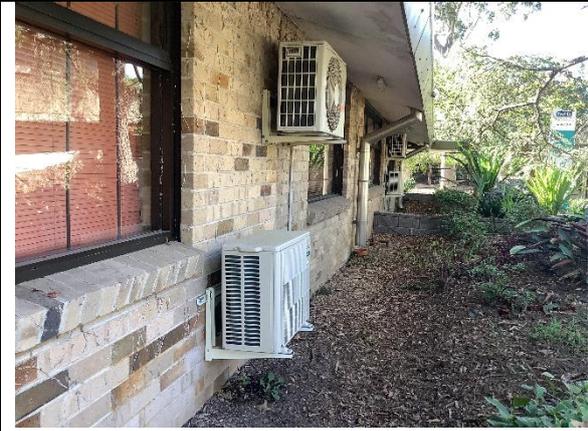
Photo 49: Building D – Throughout – A/C Units

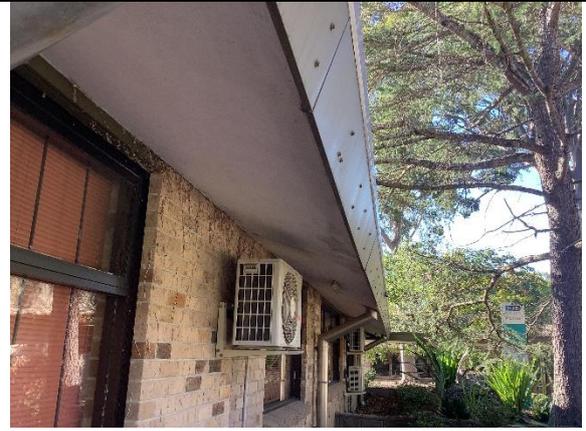
Photo 50: Building D – Throughout – Awning- Fibre Cement Sheet

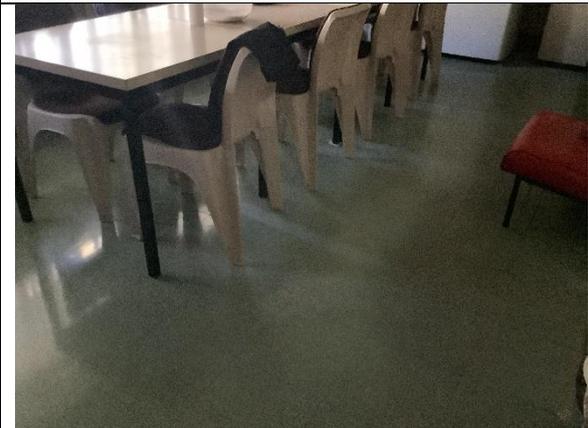
Photo 51: Building D – D.G.15 – Throughout – Floor Covering – Vinyl Tiles - Green

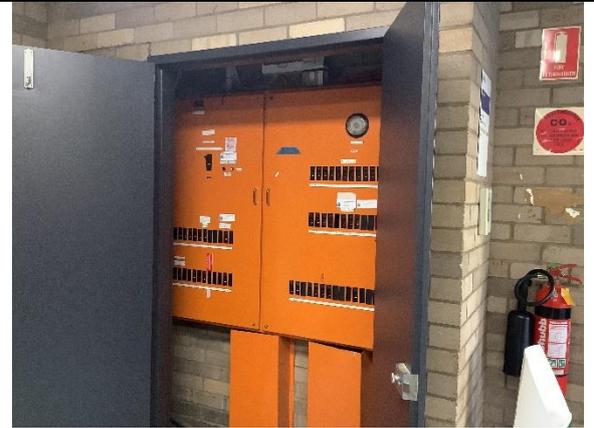
Photo 68: Building E – E.G.16 – Electrical Distribution Board – Compressed Bituminous Electrical Panel

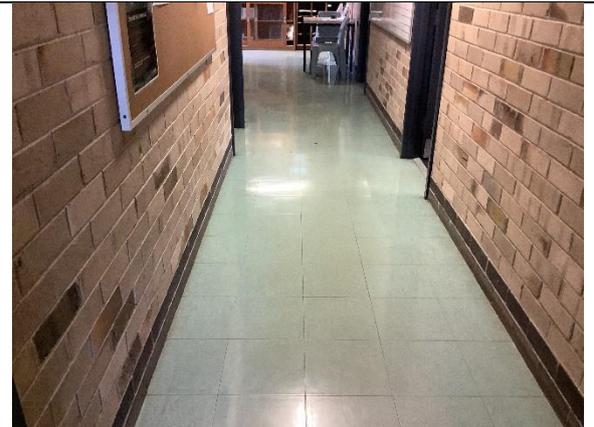
Photo 70: Building E – E.G.18 – Throughout – Floor Covering – Vinyl Tiles – Green

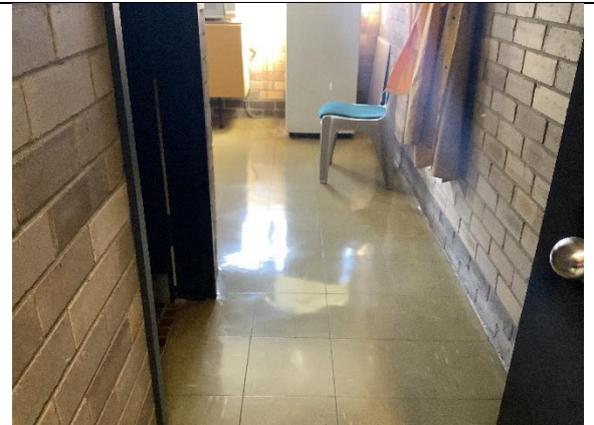
Photo 72: Building E – E.G.7 – Throughout – Floor Covering – Vinyl Tiles – Green

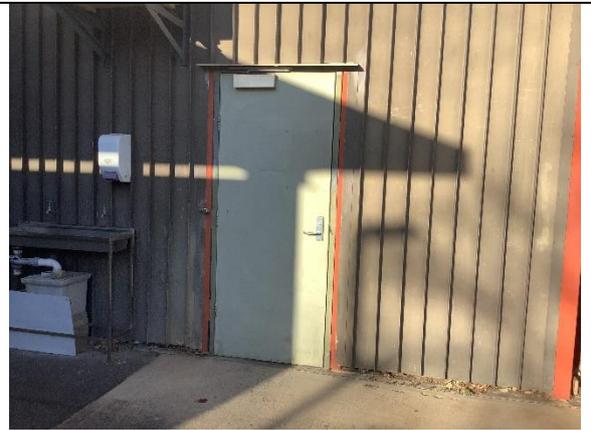
Photo 80: Building F – Throughout – Door Frames – Paint - Green

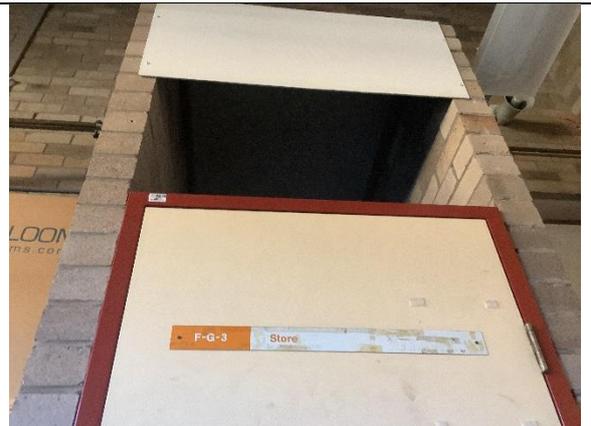
Photo 82: Building F – F.G.3 – Throughout - Ceiling – Fibre Cement Sheet

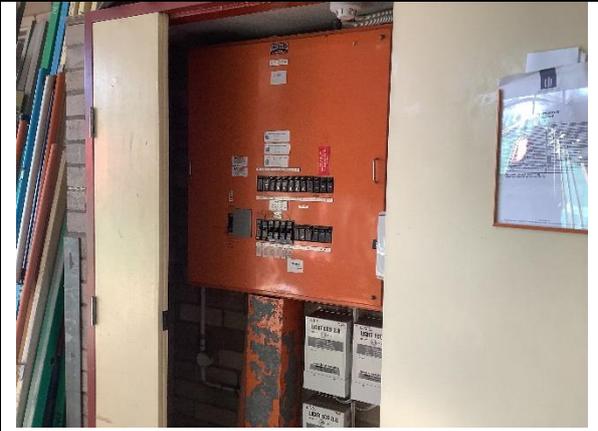
Photo 86: Building F – F.G.9 – Electrical Distribution Board – Compressed Bituminous Electrical Panel

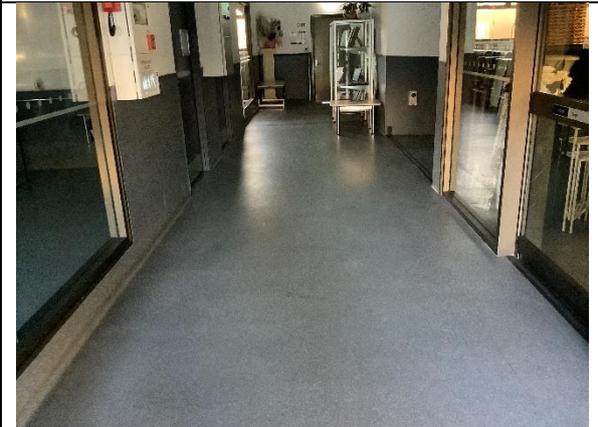
Photo 87: Building F – F.G.19 – Throughout – Floor Covering – Vinyl Sheet - Grey

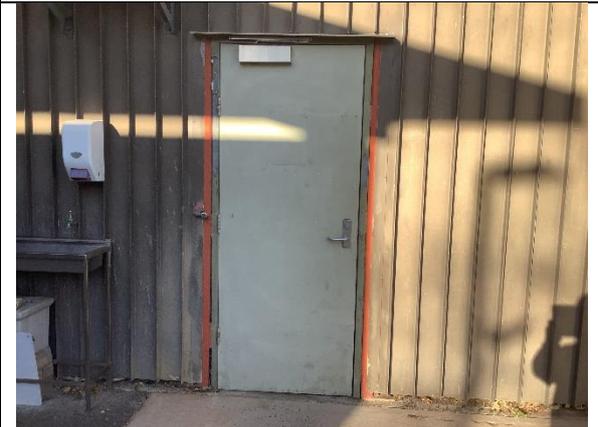
Photo 88: Building F – F.G.19 – South Exit – Fire Door – Core Insulation

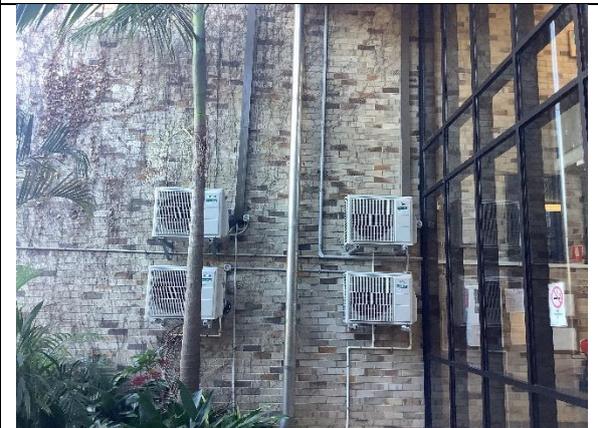
Photo 90: Building G – Throughout - A/C Units

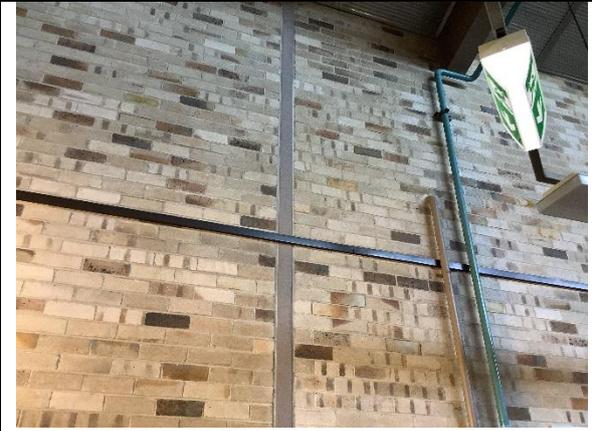
Photo 92: Building G – Throughout – Expansion Joints – Mastic - Grey

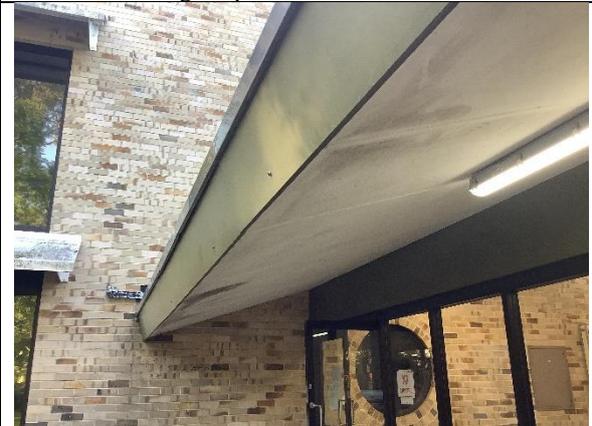
Photo 96: Building G – G.G.53 - Throughout – Awning Fibre Cement Sheet

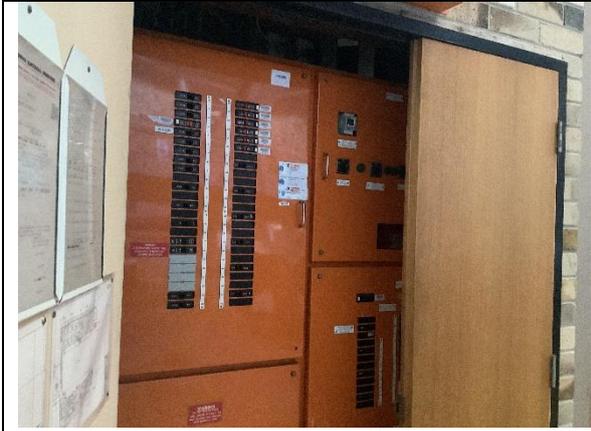
Photo 103: Building Building G – G.G.42,49a – Electrical Distribution Board – Electrical Components

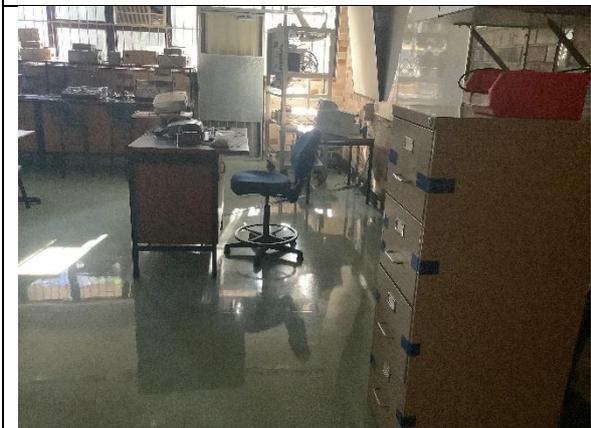
Photo 107: Building G – G.1.27 – Throughout – Floor Covering – Vinyl Tiles - Green

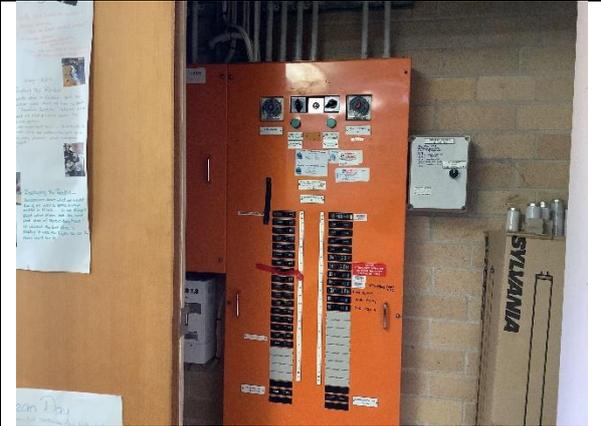
Photo 118: Building H – H.G.16 – Electrical Distribution Board – Compressed Bituminous Electrical Panel

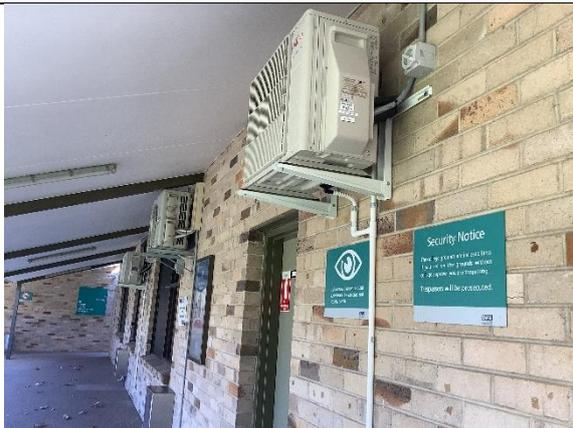
Photo 129: Building J – Throughout – Air
Conditioning Units – R32

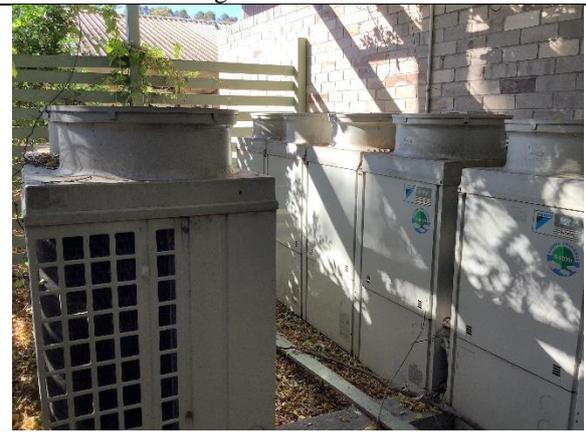
Photo 142: Building M – West – Throughout – Air Conditioning Units – R407c

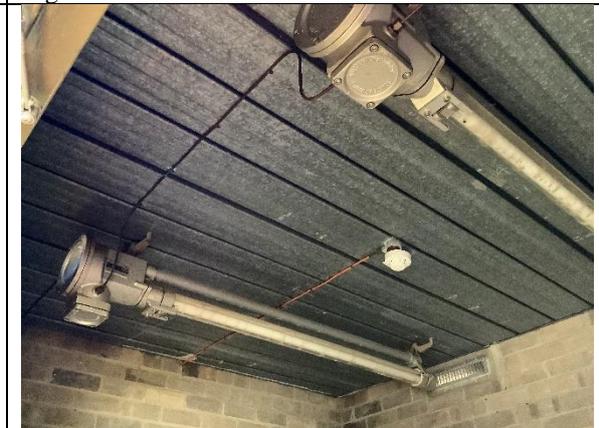
Photo 150: Building N – Various – Throughout – Light Fittings – Capacitors
