TAFE NSW

HAZARDOUS MATERIALS RESURVEYS

PADSTOW TAFE CAMPUS
RAINE RD, PADSTOW NSW 2211

DATE OF INSPECTION: 13-15 JUNE 2023

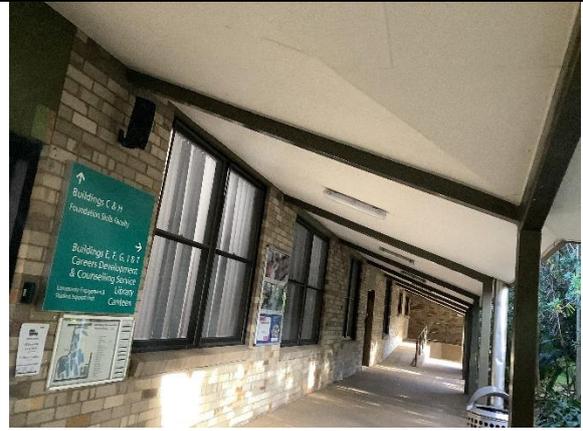
Photo 2: Throughout – Awnings – Fibre Cement Sheet – Painted White

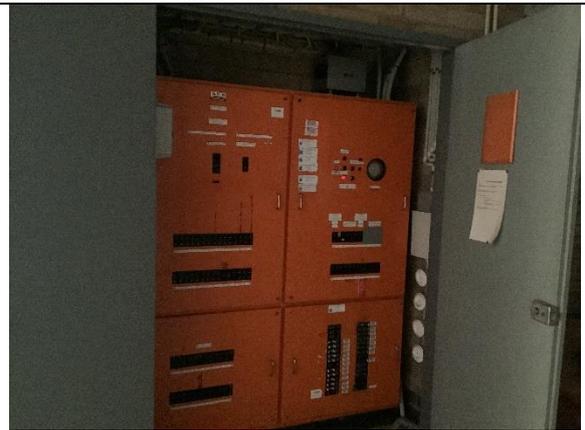
Photo 14: Building A – A.G.31 – Electrical Distribution Board – Compressed Bituminous Electrical Panel

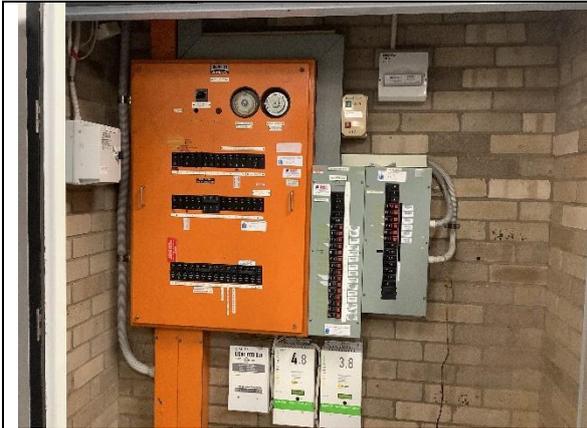
Photo 25: Building B – B.G.14 – Electrical Distribution Board – Compressed Bituminous Electrical Panel

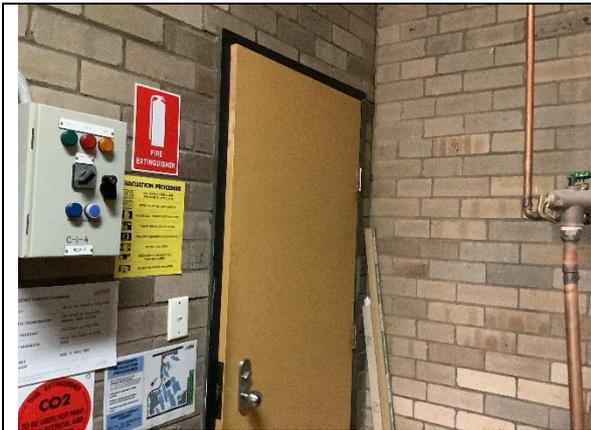
Photo 31: Building C – Throughout – Ductwork, Doors and Door Frames – Paint - Cream

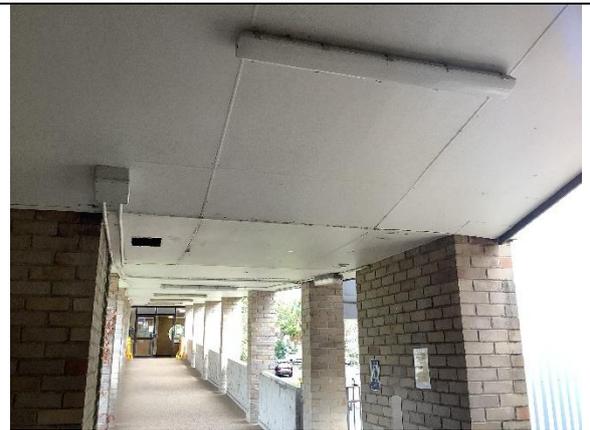
Photo 32: Building C – C.G.31 – Throughout – Awning – Fibre Cement Sheet

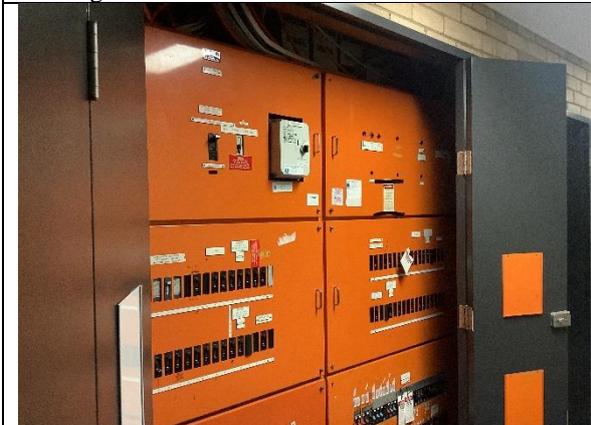
Photo 35: Building C – C.G.2 – Electrical Distribution Board – Compressed Bituminous Electrical Panel

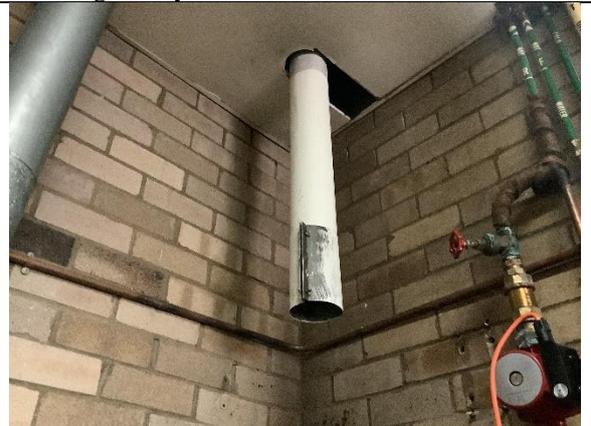
Photo 40: Building C – C.1.4 – North – Flue – Moulded Cement Flue

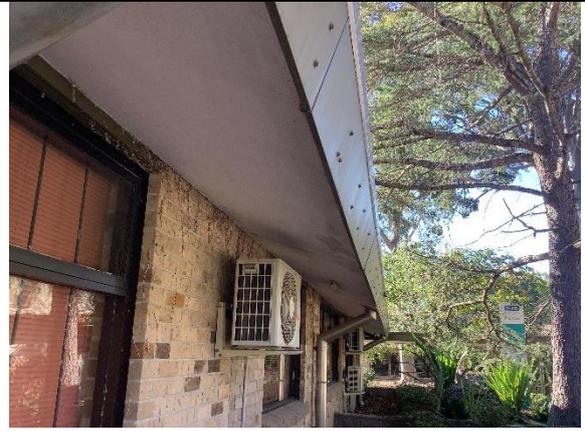
Photo 50: Building D – Throughout – Awning- Fibre Cement Sheet

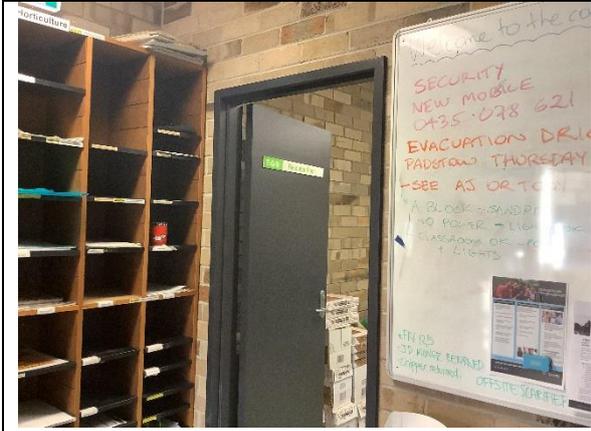
Photo 61: Building E – Throughout – Doors and door frames – Paint - Grey

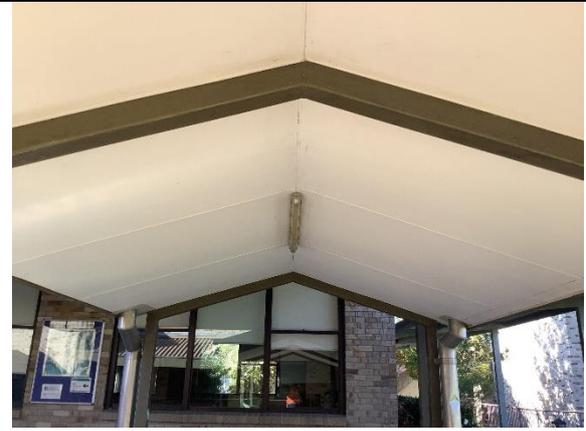
Photo 62: Building E – E.G.12 – Throughout Awning – Fibre Cement Sheet

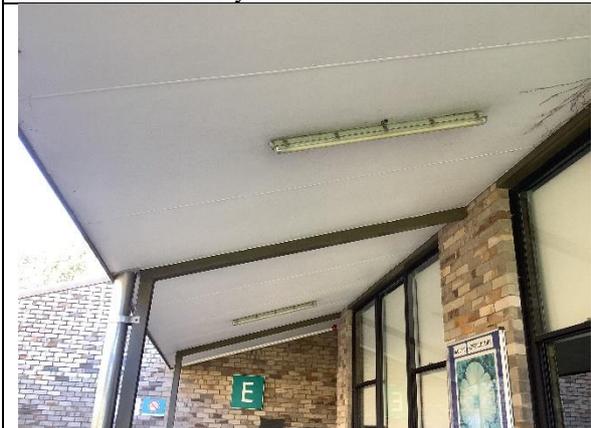
Photo 63: Building E – E.G.28 – Throughout Awning – Fibre Cement Sheet

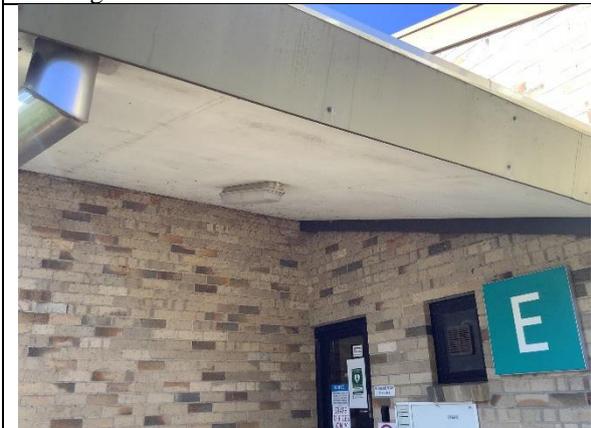
Photo 65: Building E – Exterior – Throughout Awning – Fibre Cement Sheet

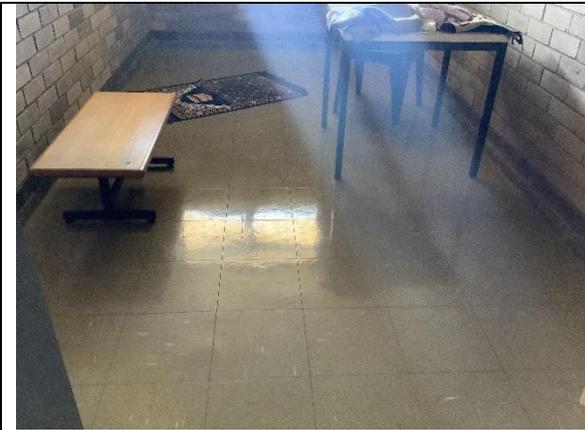
Photo 67: Building E – E.G.11 – Throughout – Floor Covering – Vinyl Tiles - Khaki

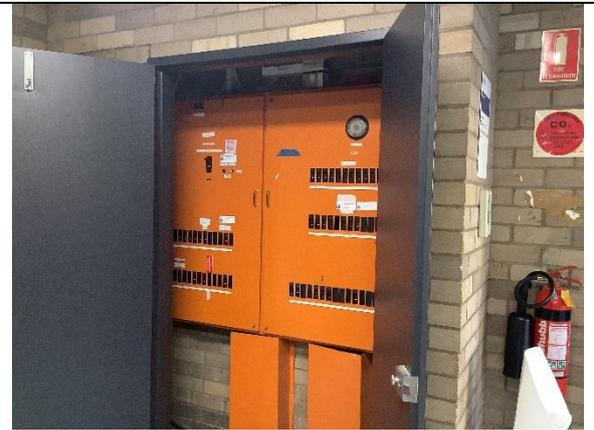
Photo 68: Building E – E.G.16 – Electrical Distribution Board – Compressed Bituminous Electrical Panel

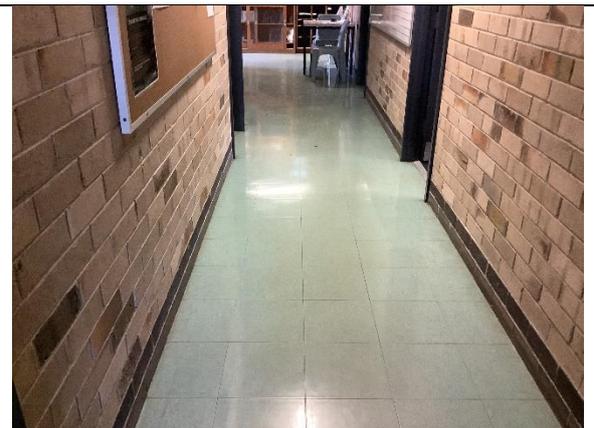
Photo 70: Building E – E.G.18 – Throughout – Floor Covering – Vinyl Tiles – Green

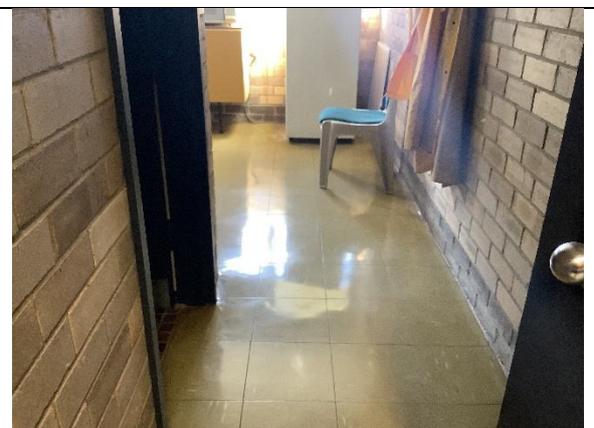
Photo 72: Building E – E.G.7 – Throughout – Floor Covering – Vinyl Tiles – Green

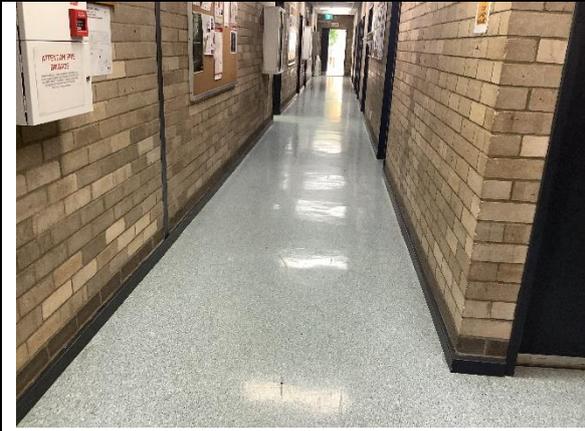
Photo 73: Building E – E.G.1-4,13– Throughout – Floor Covering – Vinyl Tiles – Grey Speckled

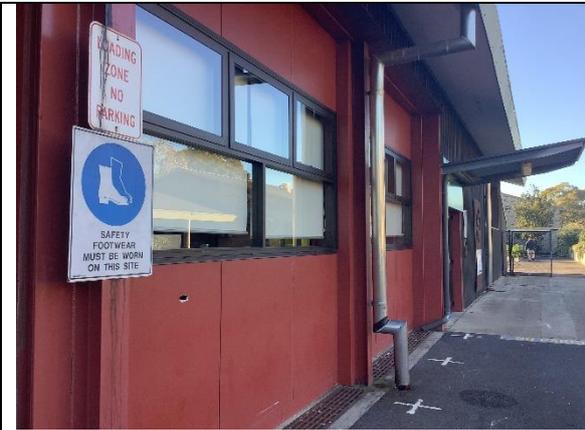
Photo 79: Building F – Various Throughout – Fibre Cement Sheet – Painted Red

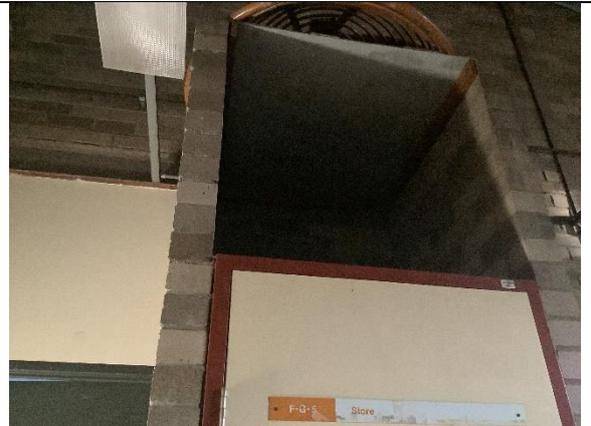
Photo 84: Building F – F.G.5 – Throughout - Ceiling – Fibre Cement Sheet

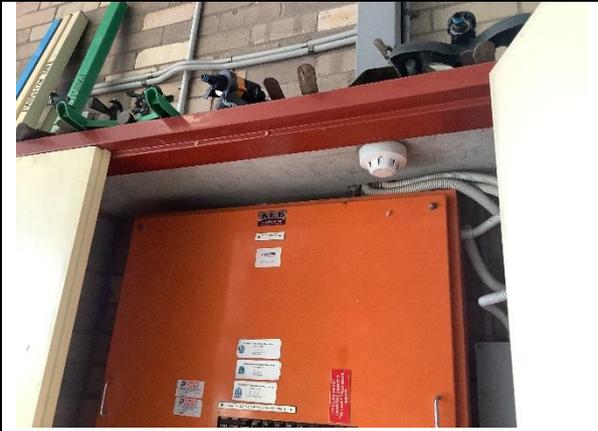
Photo 85: Building F – F.G.9 – Throughout - Ceiling – Fibre Cement Sheet

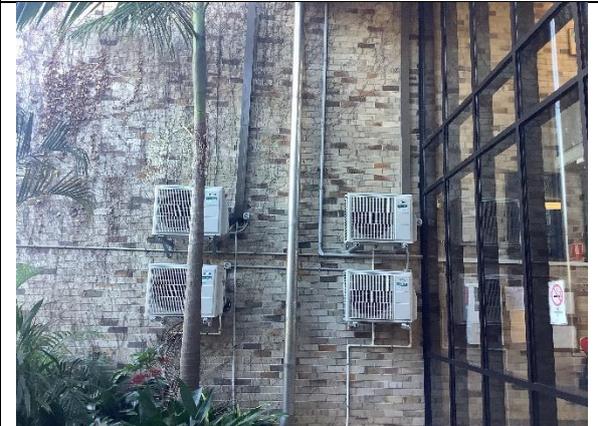
Photo 90: Building G – Throughout - A/C Units

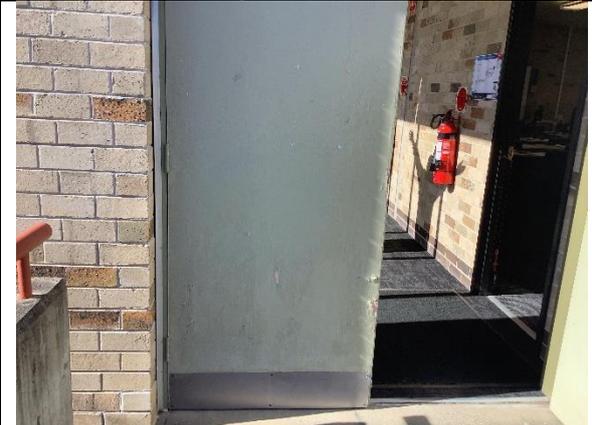
Photo 94: Building G – Throughout – Doors, Door Frames, Drainage Pipes – Paint - Green

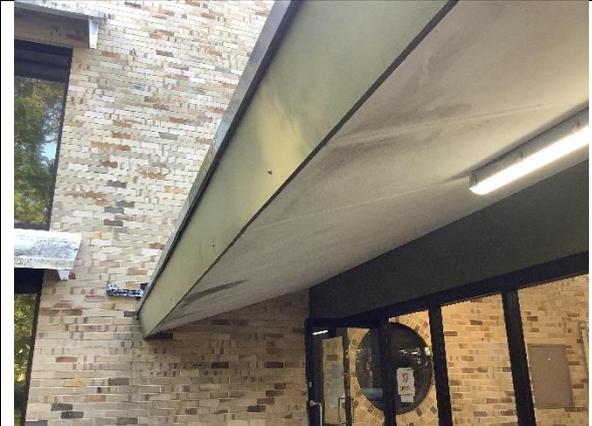
Photo 96: Building G – G.G.53 - Throughout – Awning Fibre Cement Sheet

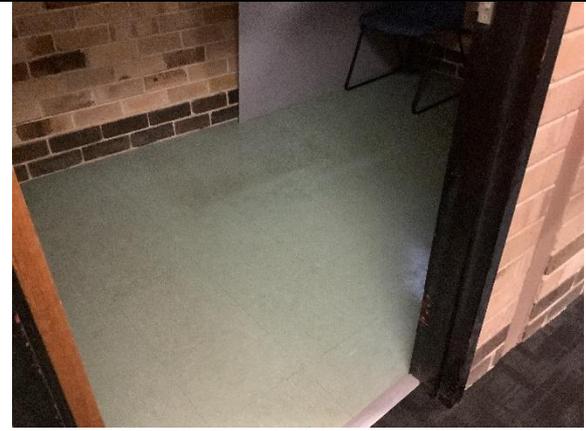
Photo 104: Building G – G.1.10 – Throughout – Floor Covering – Vinyl Tiles - Green

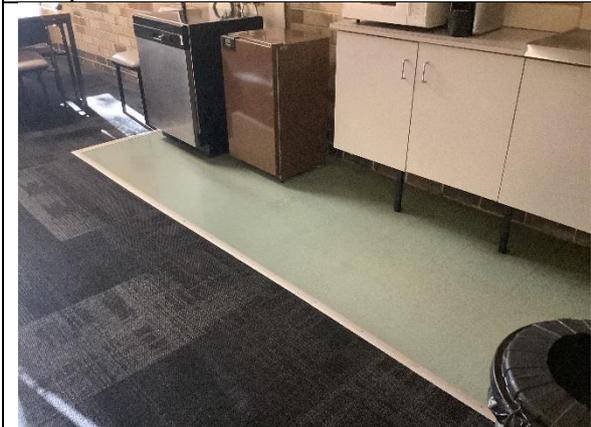
Photo 105: Building G – G.1.19 – Entrance – Floor Covering – Vinyl Tiles - Green

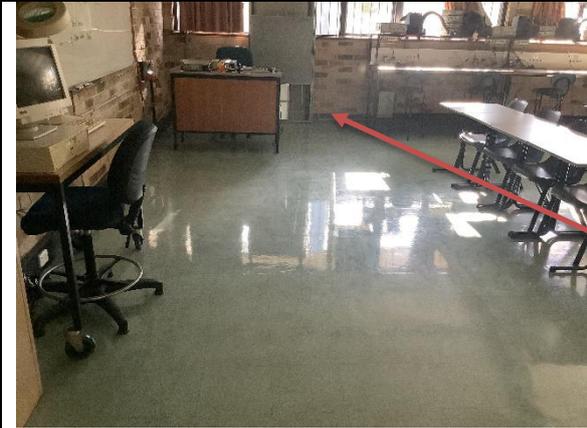
Photo 109: Building G – G.1.28 – Throughout – Floor Covering – Vinyl Tiles - Grey

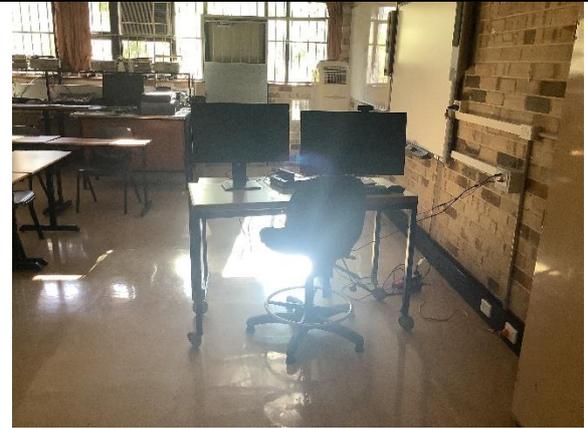
Photo 110: Building G – G.1.29 – Throughout – Floor Covering – Vinyl Tiles - Grey

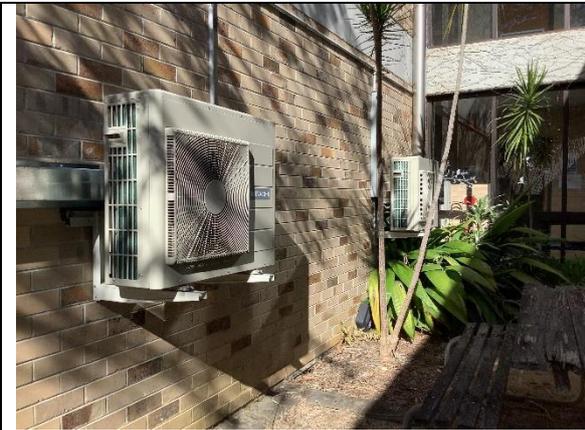
Photo 115: Building H – Throughout – A/C Units

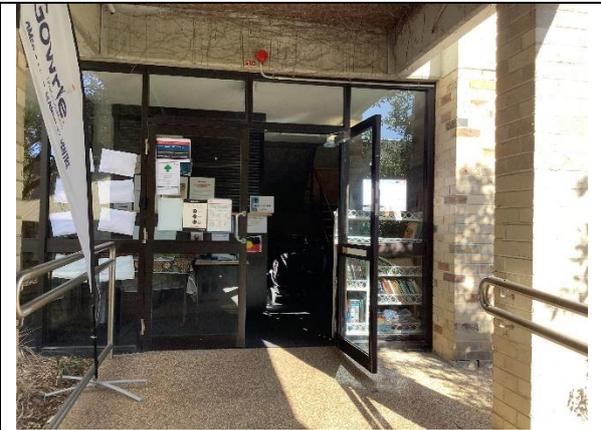
Photo 116: Building H – Throughout – Door Frames

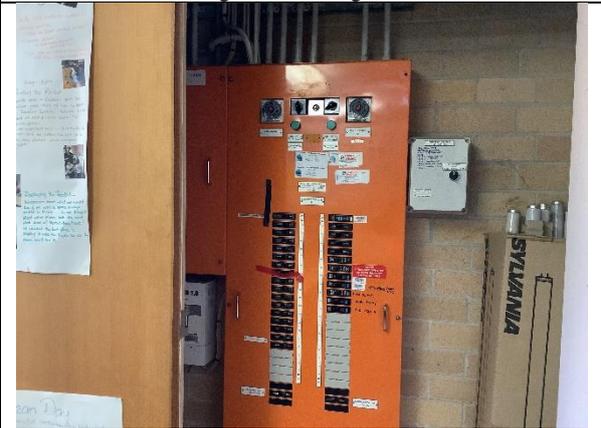
Photo 118: Building H – H.G.16 – Electrical Distribution Board – Compressed Bituminous Electrical Panel

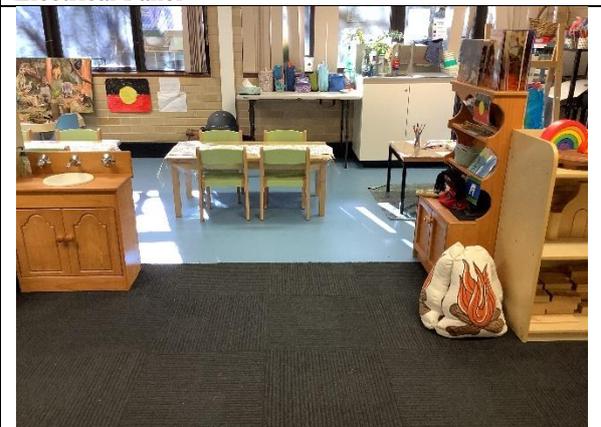
Photo 120: Building H – H.G.3,4 – Throughout – Floor Covering – Vinyl Sheet - Blue

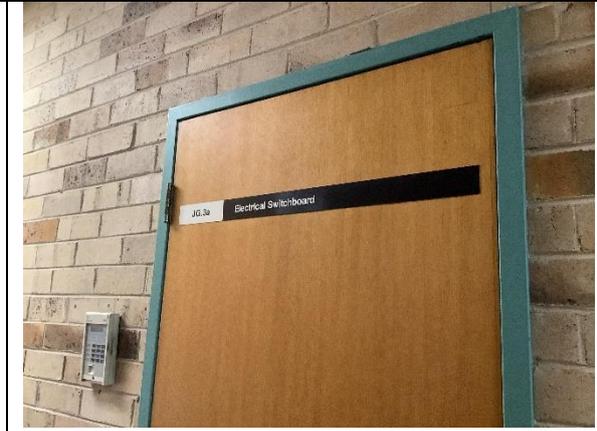
Photo 128: Building J – Various – Throughout –
Door Frames – Paint - Green

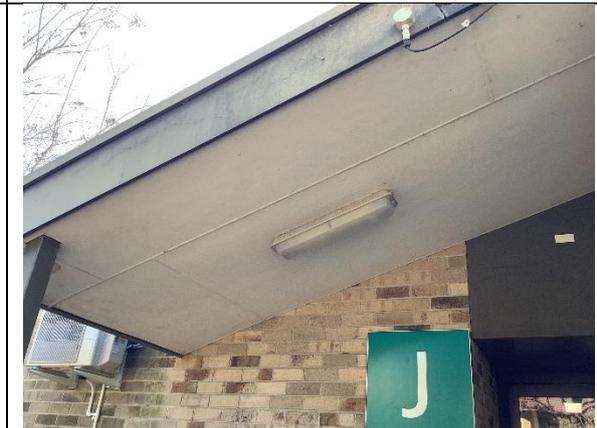
Photo 130: Building J – J.G.41 – Throughout –
Awning – Fibre Cement Sheet

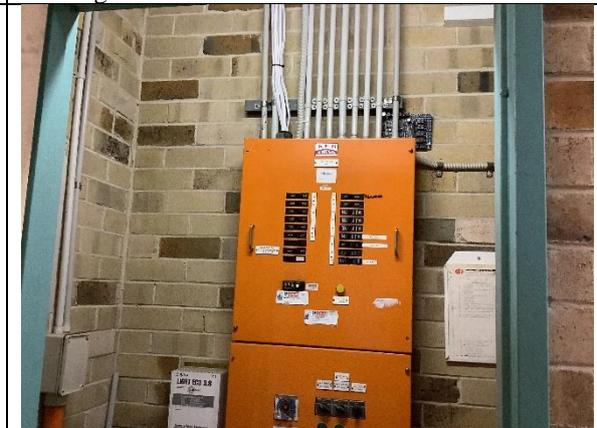
Photo 132: Building J – J.G.3a – Electrical
Distribution Board – Internal Components

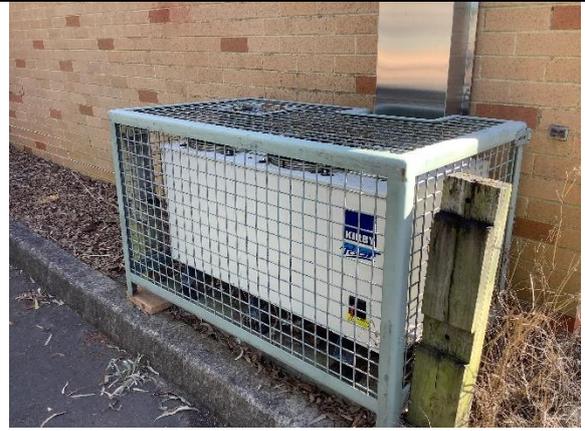
Photo 134: Building K – Various – Throughout – A/C Units

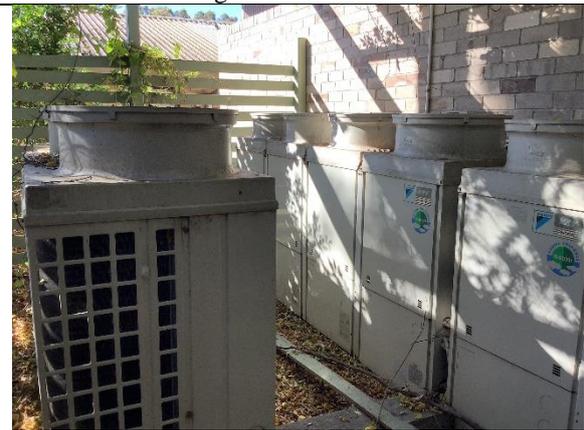
Photo 142: Building M – West – Throughout – Air Conditioning Units – R407c

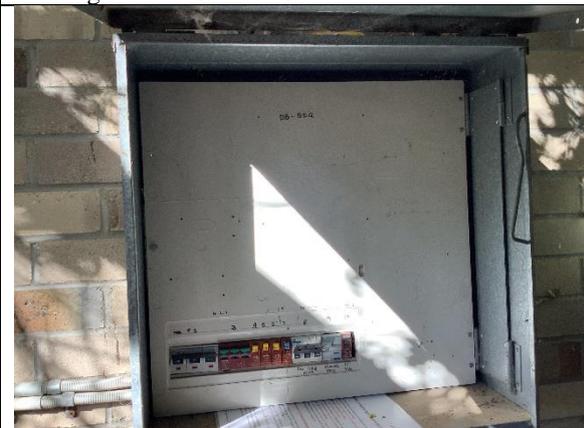
Photo 143: Building M – West – Electrical Distribution Board – Plastic Electrical Board

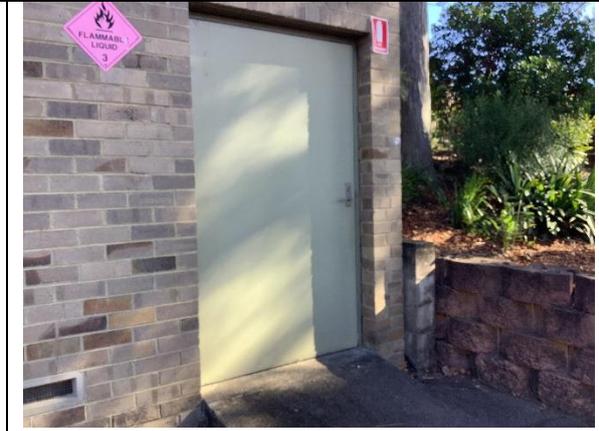
Photo 146: Building N – Various – Throughout – Doors and Door Frames – Paint - Grey

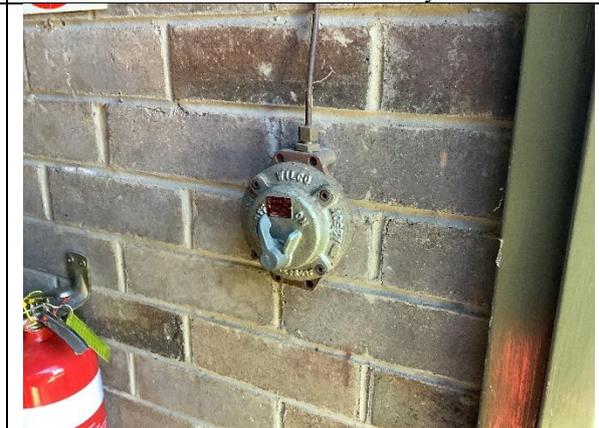
Photo 148: Building N – Various – Throughout – Light Switches – Internal Insulation
