# TAFE NSW – Padstow Campus Outdoor Air Quality Baseline Assessment

**RAINE ROAD, PADSTOW, NSW, 2211**

Report No.: 51491

May 2025

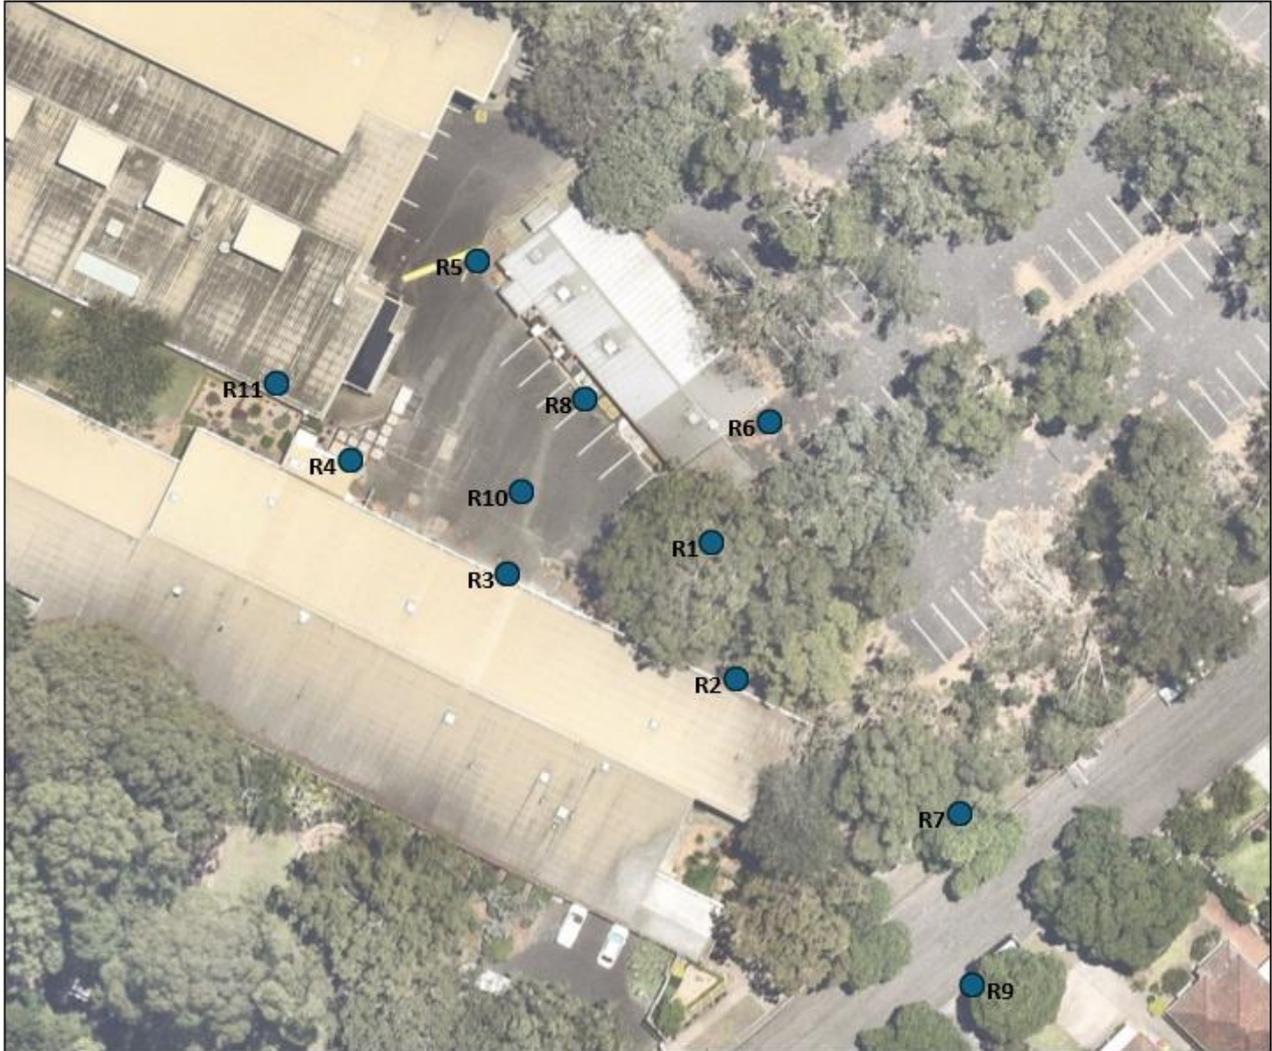
Figure 2 – Site Plan Showing Approximate Sample Locations – TAFE NSW, Padstow Campus, Raine Road, Padstow NSW

Eleven locations were sampled within and surrounding the proposed development area at TAFE NSW – Padstow Campus, Raine Road, NSW (Figure 2).

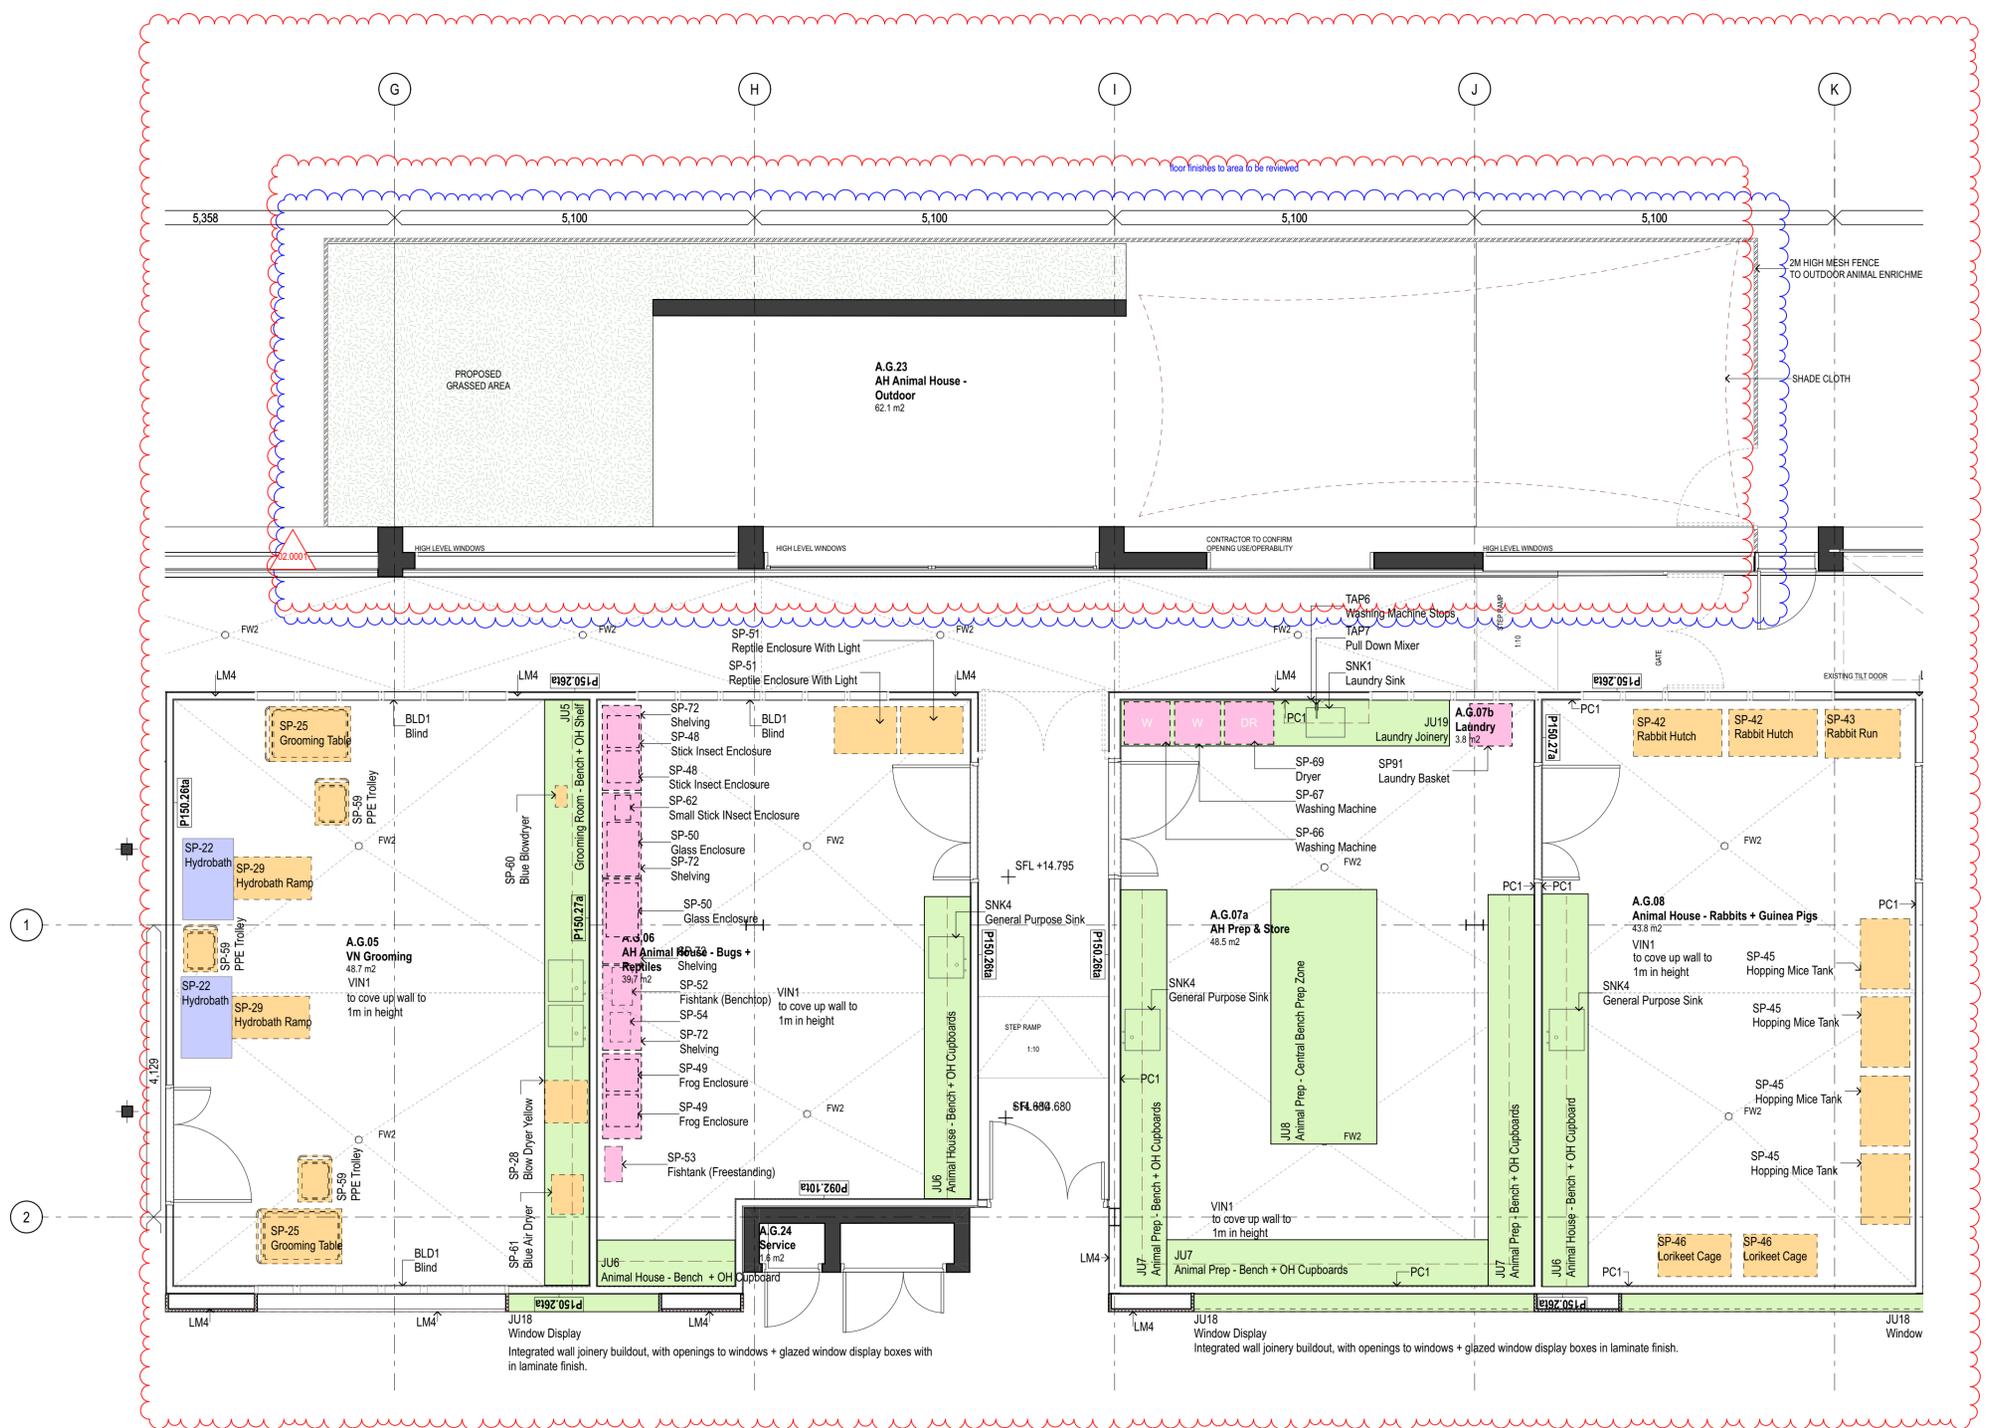
**General Purpose Classroom** Scale 1:50 @ A1  
Animal House

## APPENDIX A – Proposed Site Layout

Proposed usage of the facility is minimal. Information provided by the client representative indicates that up to 3 dogs will be housed in the facility at one time. During this time the animals will have limited time on site split between indoor and outdoor occupancy with outdoor usage expected to be for approximately one hour per day for stretching, running around etc. The proposed layout of the outdoor area is shown in Figure 3 below.

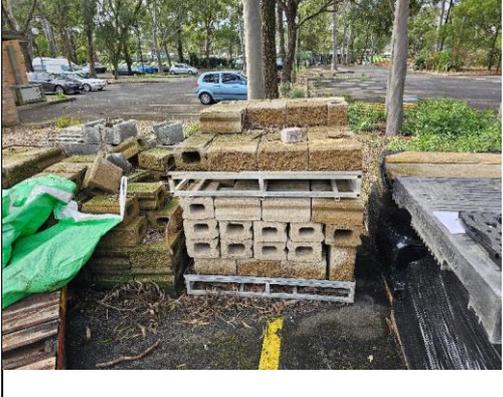
Latitude: -33.947480 Longitude: 151.026351	Reading R1  Adjacent brick stockpile  Northeastern section of proposed development area

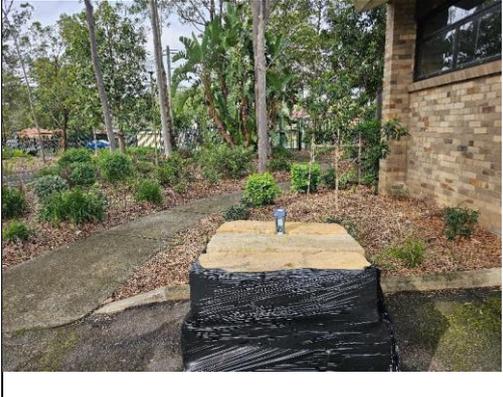
Latitude: -33.947723 Longitude: 151.026875	Reading R2  Adjacent woodchip garden bed  Eastern end of proposed development area

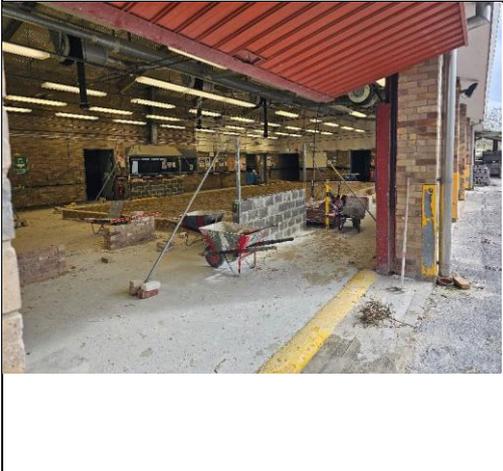
Latitude: -33.947499 Longitude: 151.026211	Reading R3  Adjacent bricklaying workshop  Southern end of proposed development area  No works undertaken during sampling period

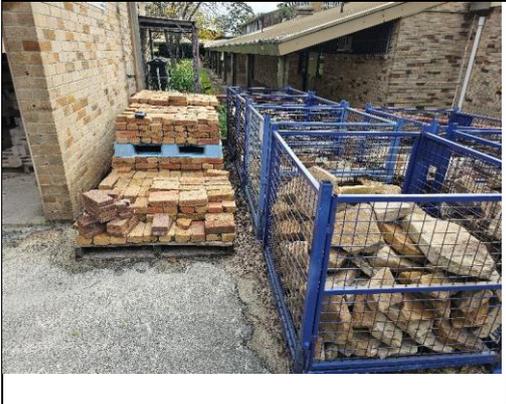
<p>Latitude: -33.947178 Longitude: 151.025846</p>	<p>Reading R4</p> <p>Adjacent undercover area on corner of A Block</p> <p>Western end of proposed development area</p>

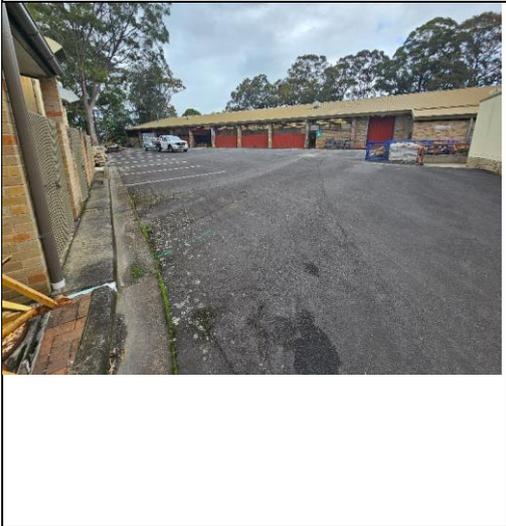
<p>Latitude: -33.947287 Longitude: 151.026043</p>	<p>Reading R5</p> <p>Adjacent toxic materials storage box on SW corner of Block K.</p> <p>Light misty rain from 8min into sample</p> <p>Northwestern end of proposed development area</p>

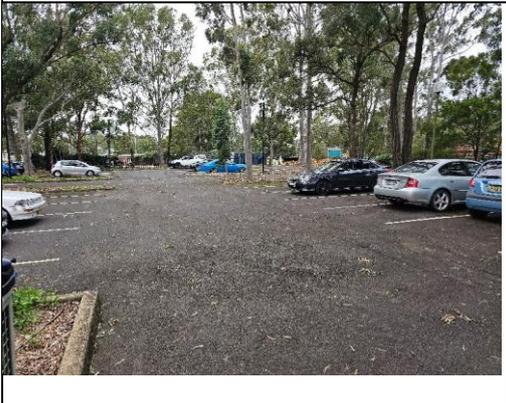
<p>Latitude: -33.947525 Longitude: 151.026462</p>	<p>Reading R6</p> <p>Adjacent flammable liquid storage unit off Block K</p> <p>Carpark northeast of the proposed development area</p>

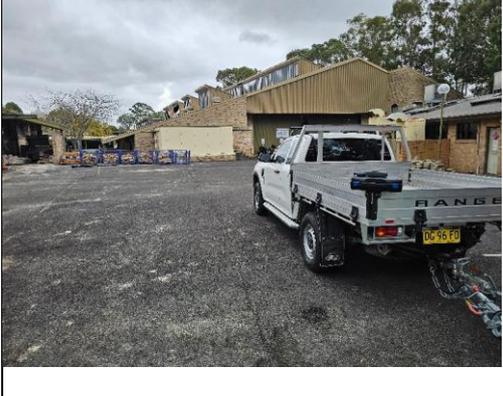
<p>Latitude: -33.947346 Longitude: 151.026257</p>	<p>Reading R10</p> <p>Centre of proposed development area</p>

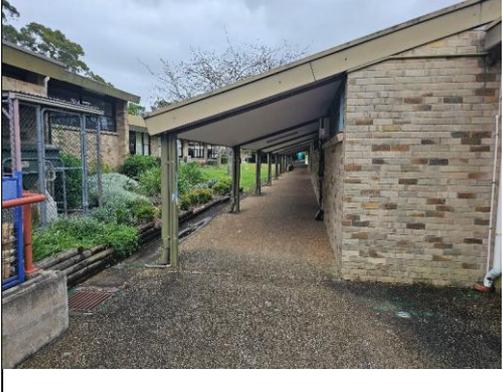
<p>Latitude: -33.947552 Longitude: 151.026147</p>	<p>Reading R11</p> <p>Below covered walkway of Block G</p> <p>West of proposed development area</p>

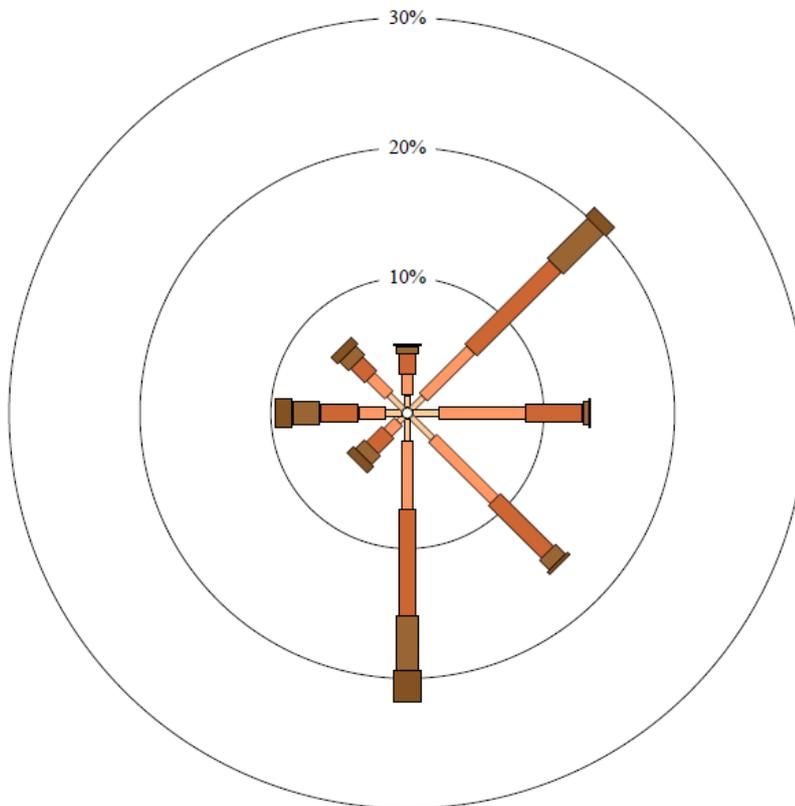
3 pm  
28945 Total Observations

### Rose of Wind direction versus Wind speed in km/h (01 Apr 1939 to 31 Jul 2019)

Calm 2%

This is consistent with the 9am Rose of Wind Direction of the Sydney Airport (closest location) presented in Appendix D, which shows from 1939-2019 the average wind direction is West to North West, whilst the 3pm average wind direction for the same time period is North-east to Southern.

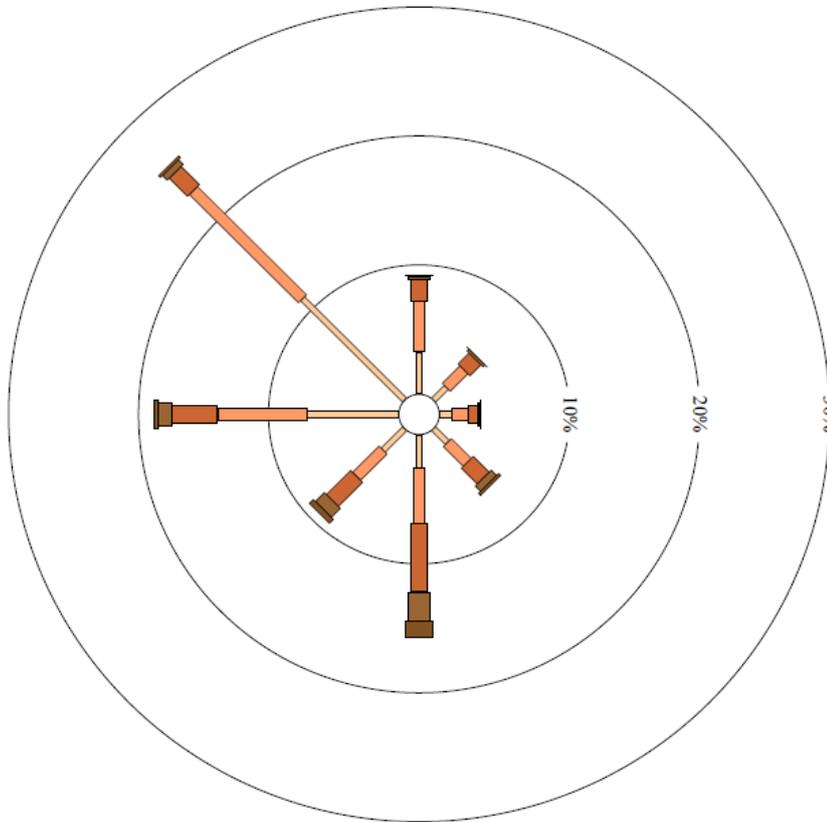
9 am  
28871 Total Observations

Rose of Wind direction versus Wind speed in km/h (01 Apr 1939 to 31 Jul 2019)

Calm 8%
