SK-CI001 - Block A HAZMAT Demolition Plan
 Revision A - 25 May 2025

HAZARDOUS MATERIALS RESURVEYS

PADSTOW TAFE CAMPUS
RAINE RD, PADSTOW NSW 2211

Hazardous Materials Resurveys
Padstow TAFE Campus
Raine Rd, Padstow NSW 2211

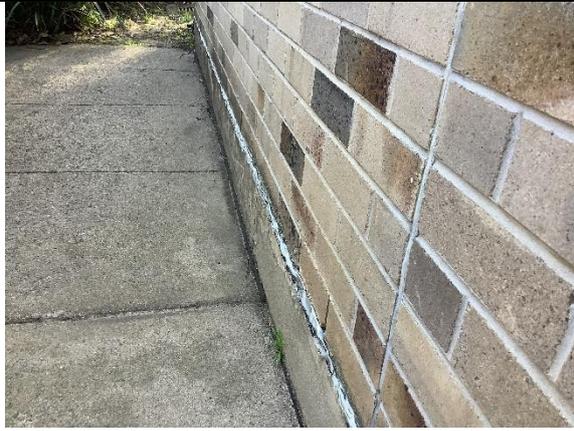
Photo 1: Concrete Slabs and Pathways - Bituminous Membrane

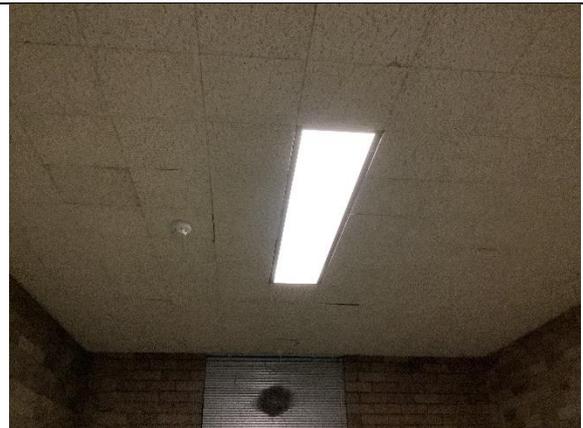
Photo 4: Building A – Throughout – Fluorescent Light Fitting – New Appearance

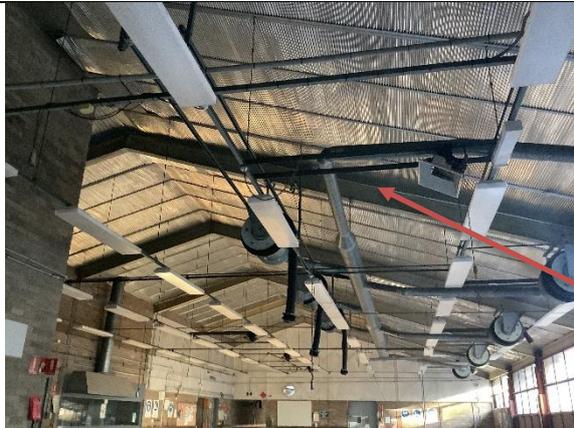
Photo 5: Building A – Throughout – SMF Insulation

Actions for HAZMAT Detected Throughout SMF
 observed within hot water heater pipework insulation and ceiling tiles to be removed under controlled conditions prior to refurb.

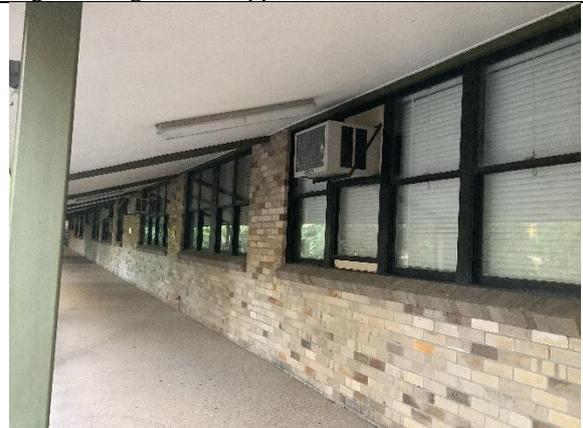
Photo 6: Building A – Throughout – A/C Units

ODS
 observed within existing AC units, o be removed under controlled conditions prior to refurb.

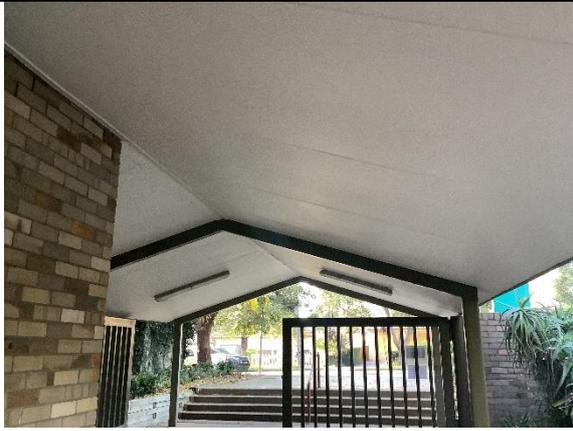
Photo 7: Building A – Throughout – Awnings – Fibre Cement Sheet – Painted White

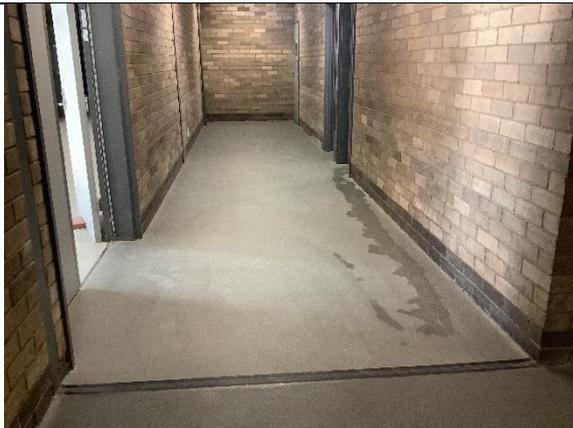
Photo 9: Building A – A.G.1-15 – Throughout – Floor – Floor Covering – Vinyl Sheet - Light

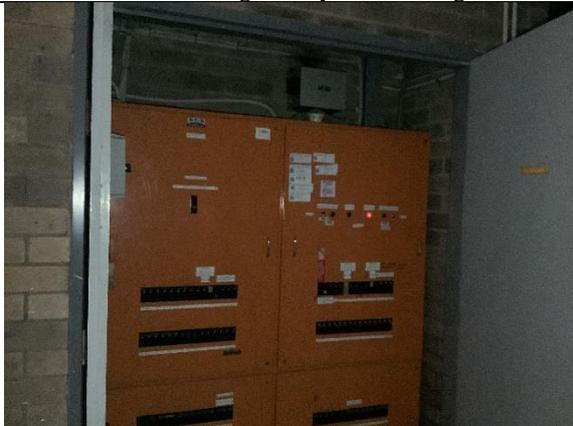
Photo 11: Building A – A.G.21 – Electrical Distribution Board – Compressed Bituminous Electrical Panel

Presumed Asbestos within compressed bituminous switchboard panels referenced in HAZMAT survey was removed during install of new switchboard by TAFE in 2025.
 No labelling or management requirements.

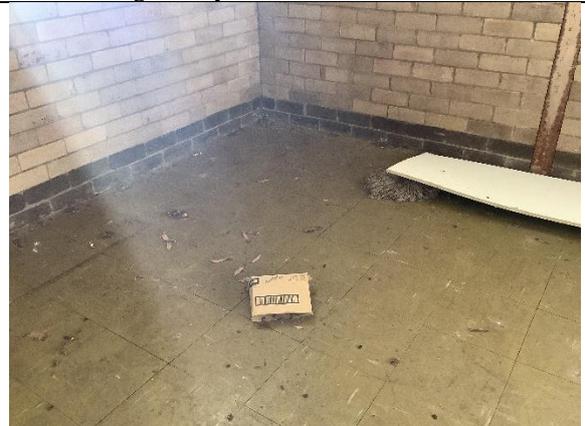
Photo 12: Building A – A.G.2,33 – Throughout – Floor Covering – Vinyl Tiles - Khaki

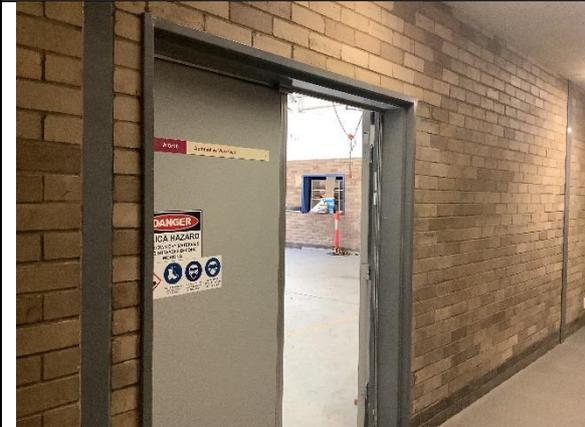
Photo 15: Building A – All Rooms – Door Frames - Paint - Grey

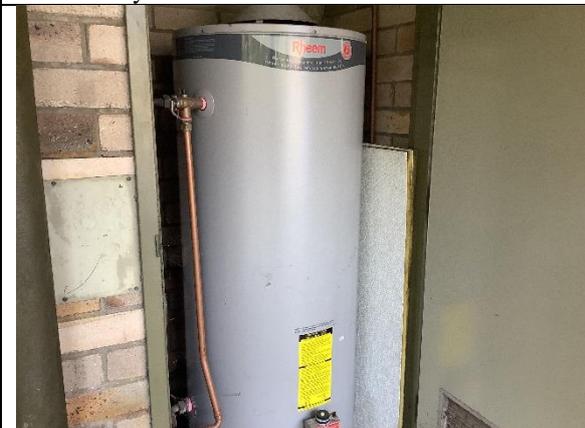
Photo 17: Building B – Throughout – SMF insulation

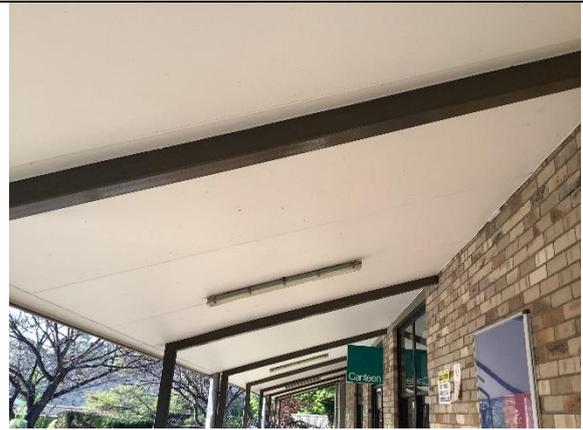
Photo 20: Building B – B.G.23 – Throughout – Awning – Fibre Cement Sheet

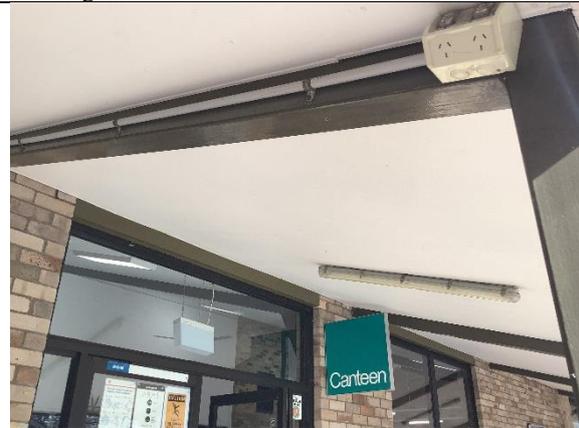
Photo 21: Building B – B.G.30 – Throughout – Awning – Fibre Cement Sheet

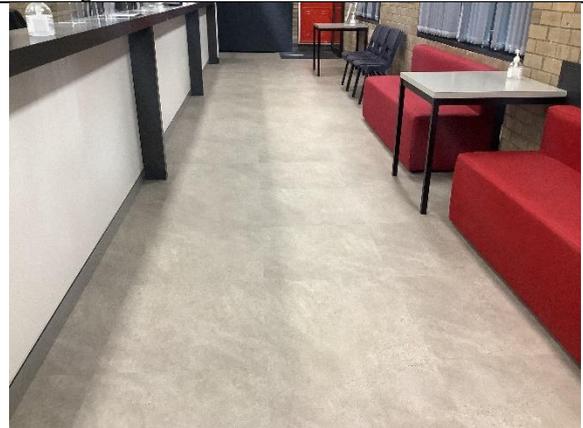
Photo 22: Building B – B.G.2 and 20 – Throughout – Floor Covering – Vinyl Tile - Grey

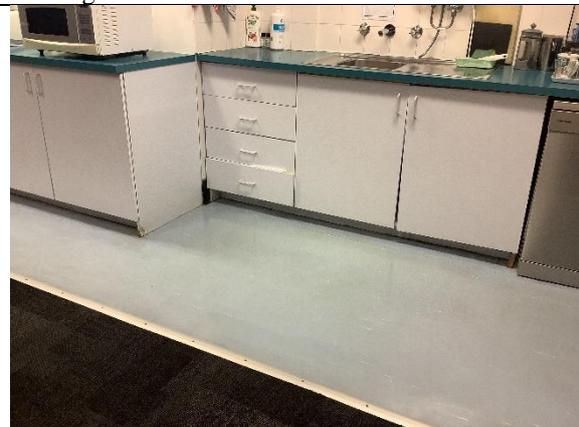
Photo 23: Building B – B.G.7 – Throughout – Floor Covering – Vinyl Sheet - Blue

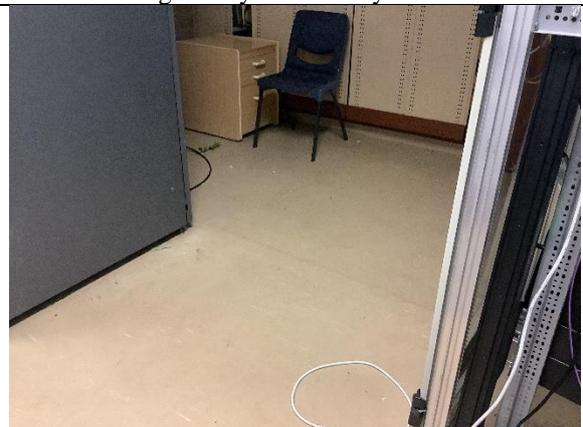
Photo 24: Building B – B.G.12 – Throughout – Floor Covering – Vinyl Sheet - Brown

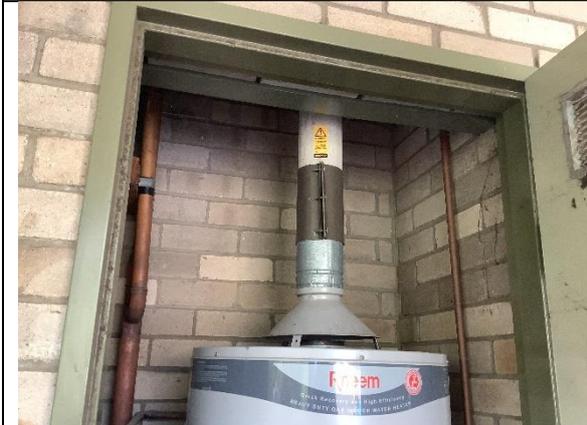
Photo 27: Building B – B.G.35 – Hot Water Service – Pipe – Cement Sheet Flue

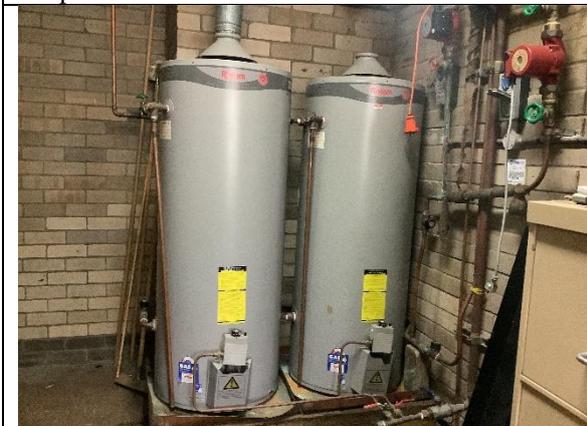
Photo 29: Building C – Throughout – SMF Insulation

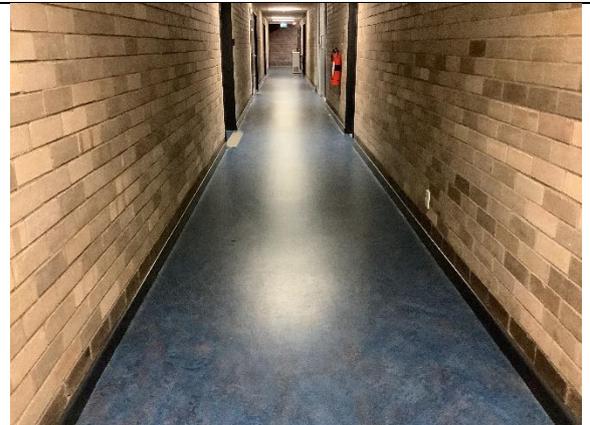
Photo 36: Building C – C.G.11 – Throughout – Floor Covering – Vinyl Sheet – Hessian Backed - Blue

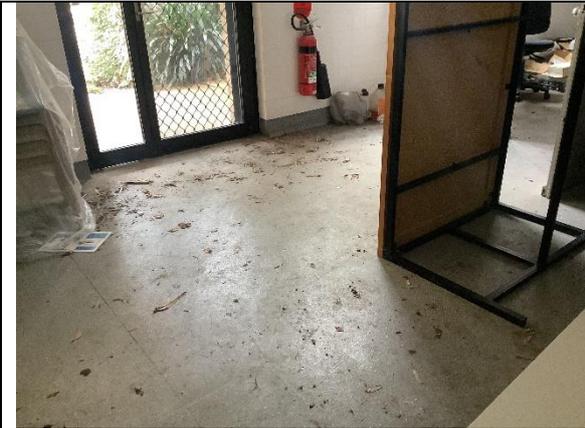
Photo 37: Building C – C.G.15,16,17,29 – Throughout – Floor Covering – Vinyl Sheet - Grey

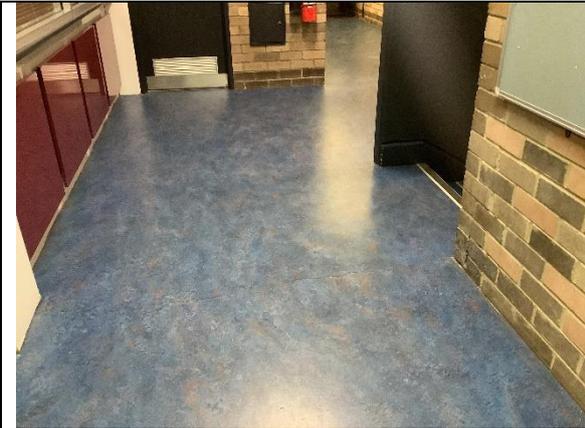
Photo 43: Building C – C.1.28 – Throughout – Floor Covering – Vinyl Sheet – Hessian Backed - Blue

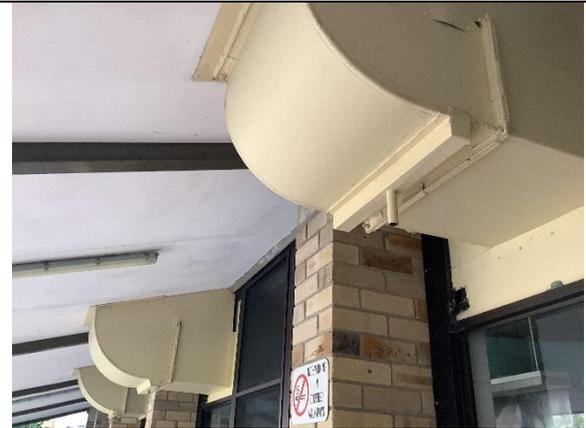
Photo 44: Building C – C.G.31 – Ductwork Flange Joint - Mastic

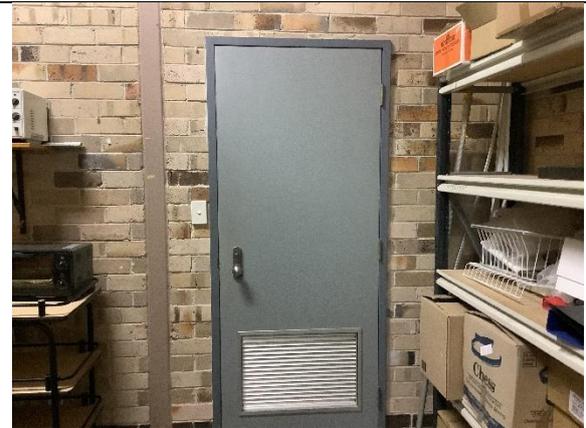
Photo 46: Building D – Throughout – Door Frames – Paint - Grey

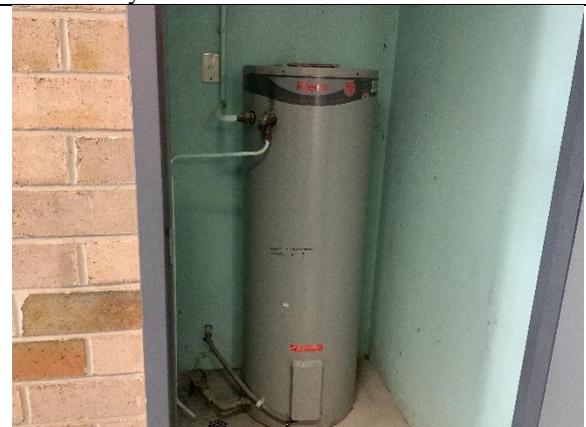
Photo 48: Building D – Throughout – SMF Insulation

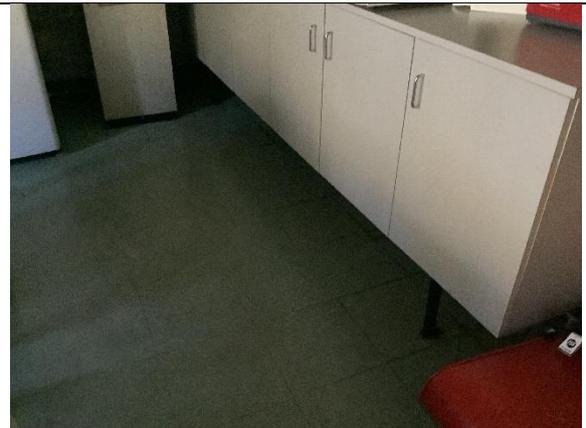
Photo 52: Building D – D.G.16 – Throughout – Floor Covering – Vinyl Tiles - Green

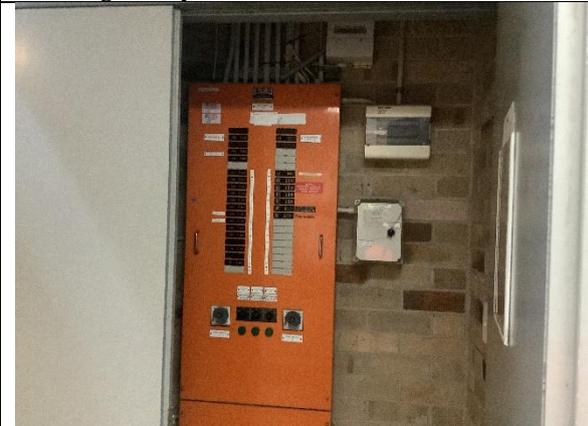
Photo 53: Building D – D.G.21 – Electrical Distribution Board – Compressed Bituminous Electrical Panel

Presumed Asbestos within compressed bituminous switchboard panels to be retained on site and labelled and incorporated into a Hazard Materials Management Plan.

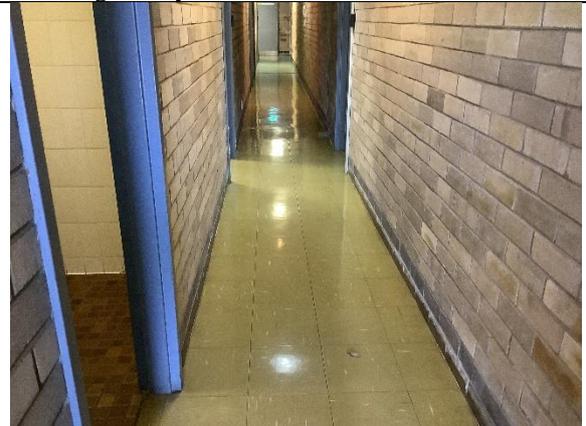
Photo 54: Building D – D.G.25 – Throughout – Floor Covering – Vinyl Tiles - Khaki

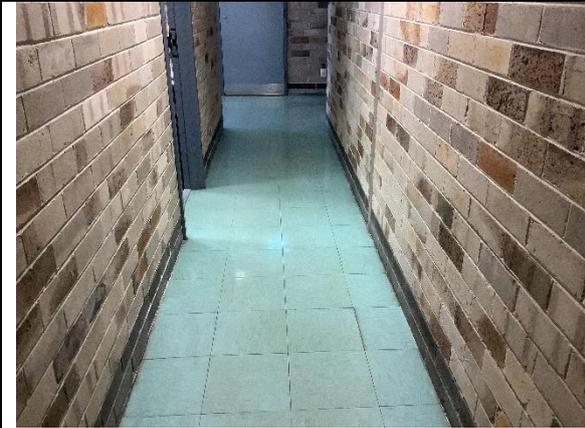
Photo 55: Building D – D.G.25 – Throughout – Floor Covering – Vinyl Tiles - Green

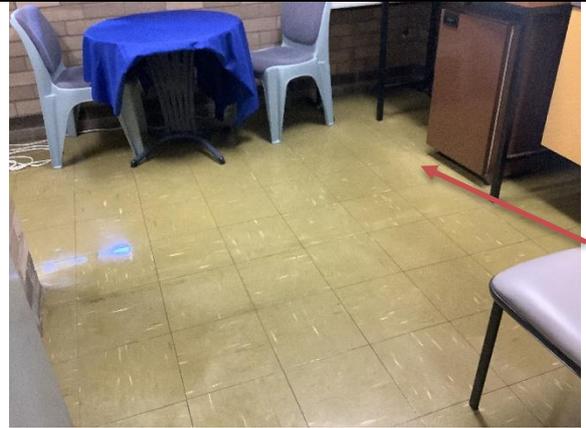
Photo 56: Building D – D.G.3 – Throughout – Floor Covering – Vinyl Tiles - Khaki

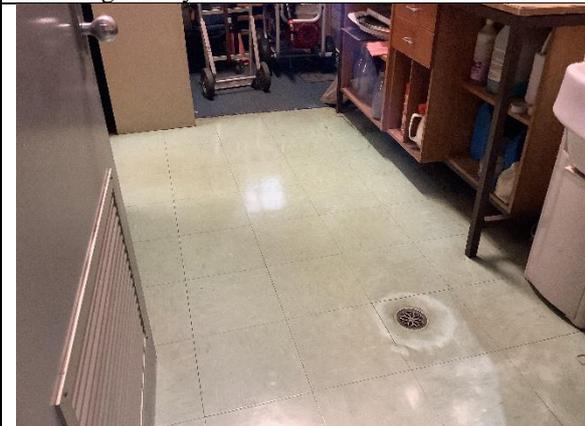
Photo 57: Building D – D.G.8 – Throughout – Floor Covering – Vinyl Tiles - Green

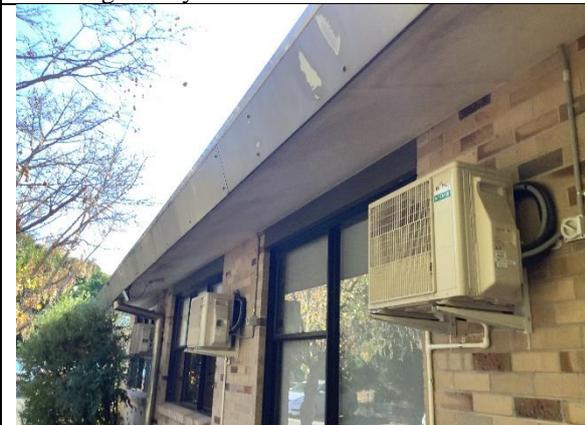
Photo 59: Building E – Throughout - A/C Units

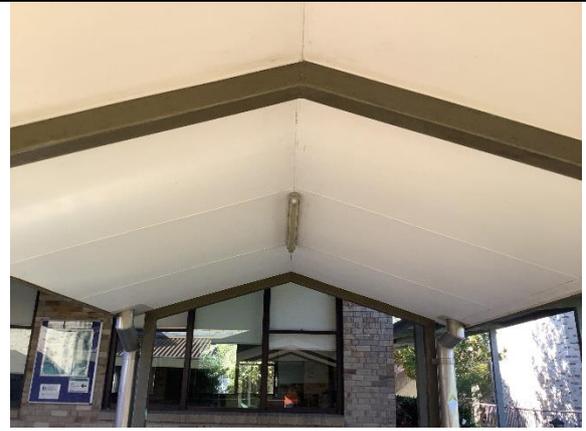
Photo 62: Building E – E.G.12 – Throughout Awning – Fibre Cement Sheet

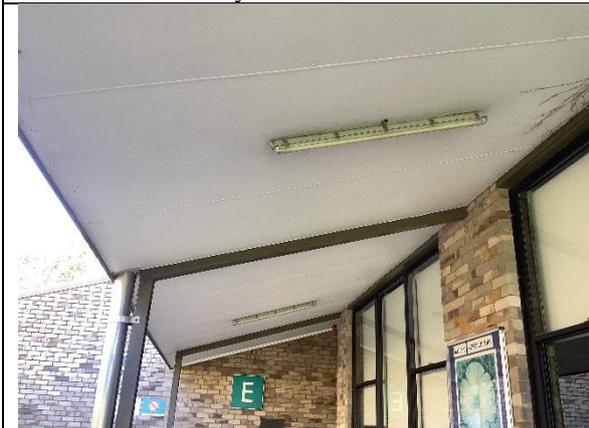
Photo 63: Building E – E.G.28 – Throughout Awning – Fibre Cement Sheet

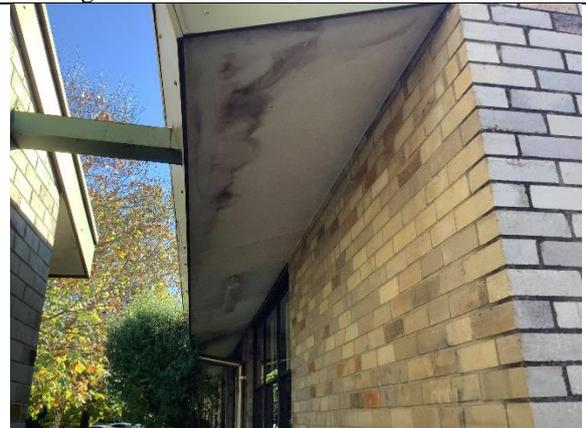
Photo 64: Building E – E.G.6 – Throughout Awning – Fibre Cement Sheet

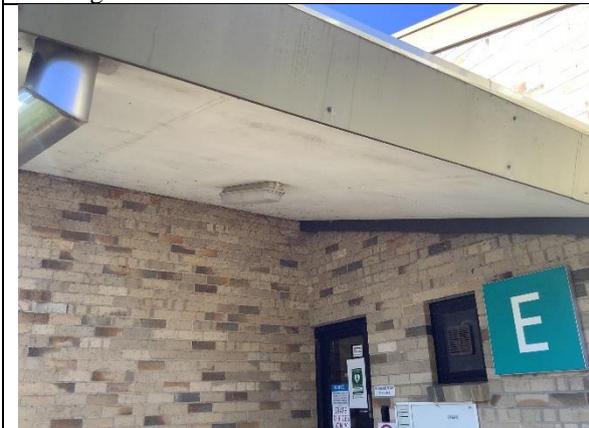
Photo 65: Building E – Exterior – Throughout Awning – Fibre Cement Sheet

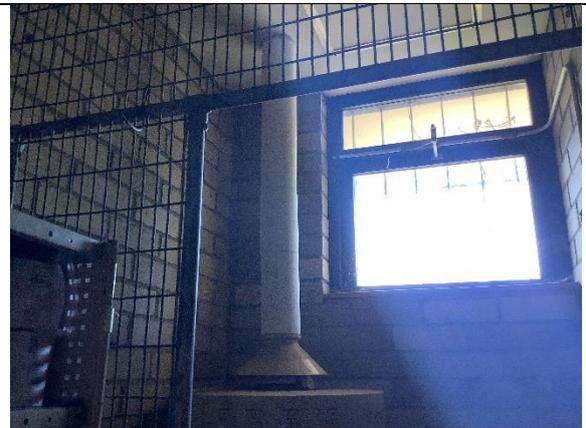
Photo 66: Building E – E.G.10 – North – Flue – Moulded Cement Flue

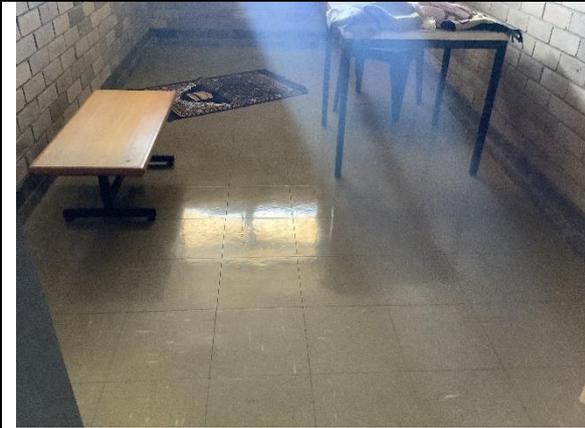
Photo 67: Building E – E.G.11 – Throughout – Floor Covering – Vinyl Tiles - Khaki

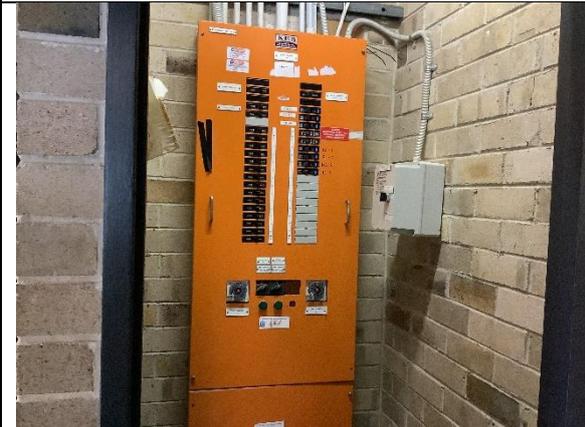
Photo 69: Building E – E.G.28 – Electrical Distribution Board – Compressed Bituminous Electrical Panel

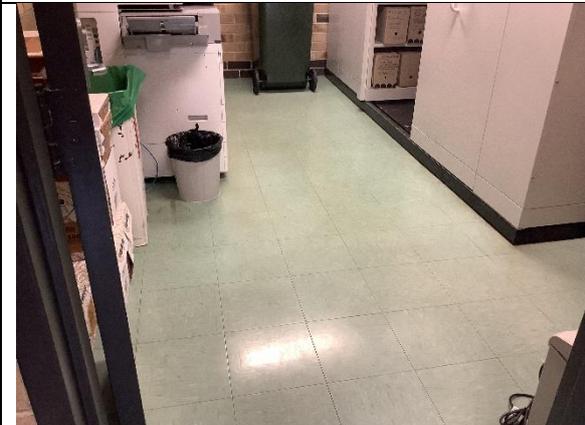
Photo 71: Building E – E.G.19 – Throughout – Floor Covering – Vinyl Tiles – Green

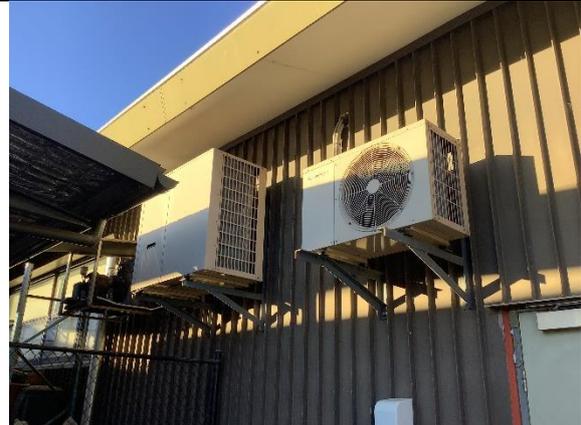
Photo 76: Building F – Throughout – A/C Units

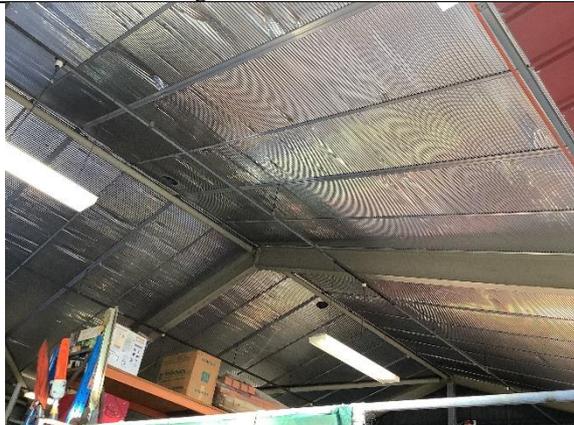
Photo 77: Building F – Throughout – SMF insulation

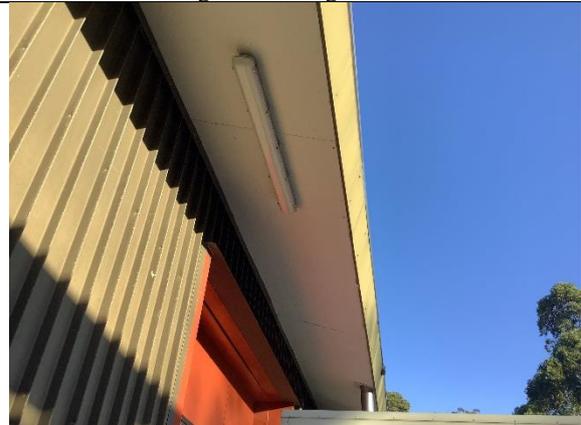
Photo 78: Building F – Throughout - Awning – Fibre Cement Sheet

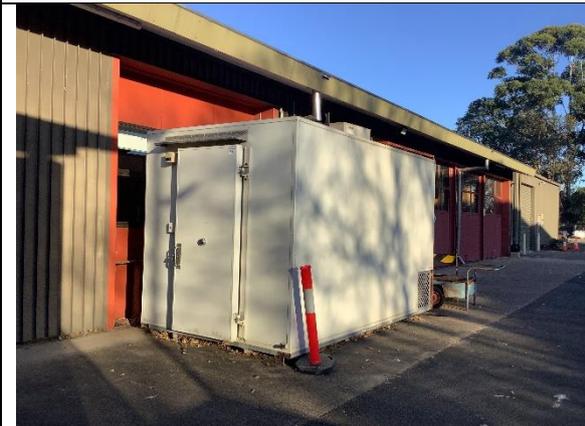
Photo 81: Building F – Adjacent F.G.24 – Cool Room – Cooling Unit – R134a

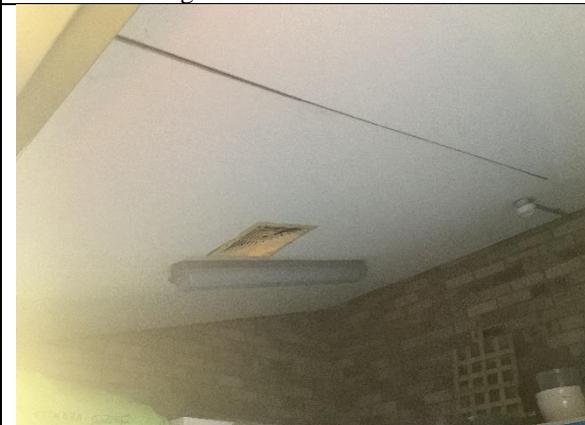
Photo 83: Building F – F.G.4 – Throughout - Ceiling – Fibre Cement Sheet

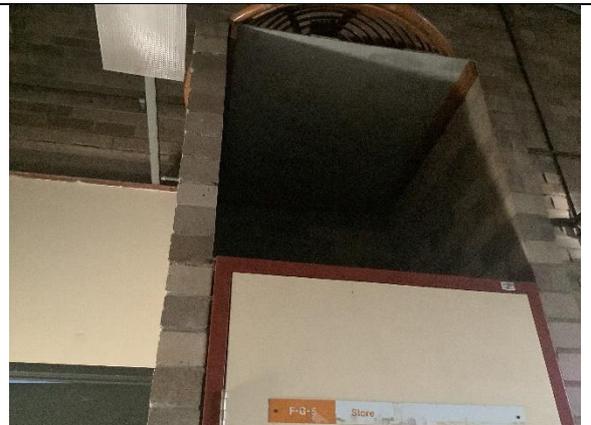
Photo 84: Building F – F.G.5 – Throughout - Ceiling – Fibre Cement Sheet

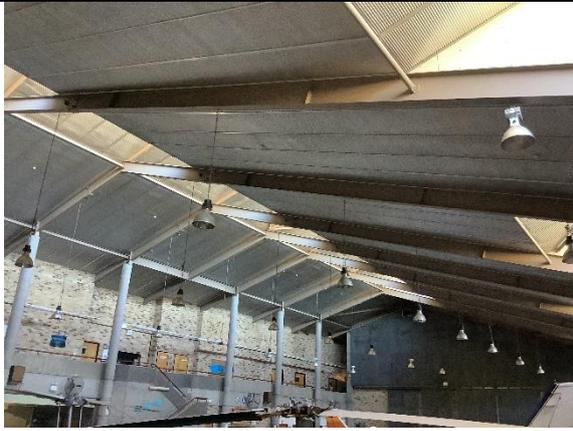
Photo 91: Building G – Throughout – SMF insulation

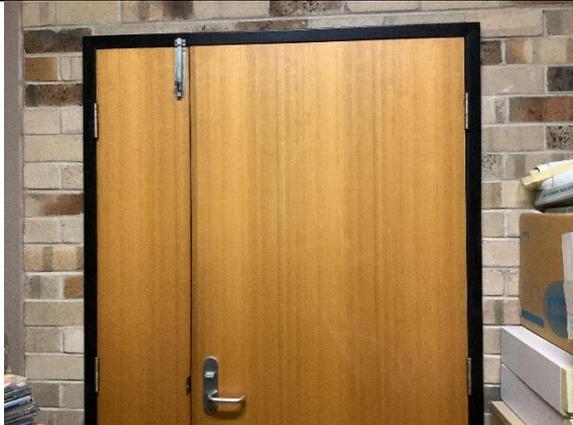
Photo 93: Building G – Throughout – Door Frames – Paint- Grey

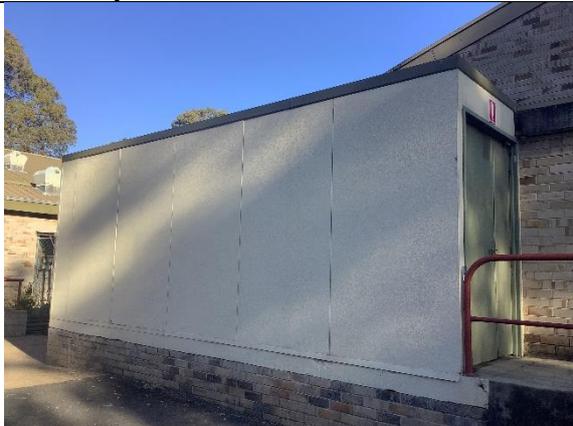
Photo 95: Building G – G.G.53 - Central Partition Wall – Fibre Cement Sheet

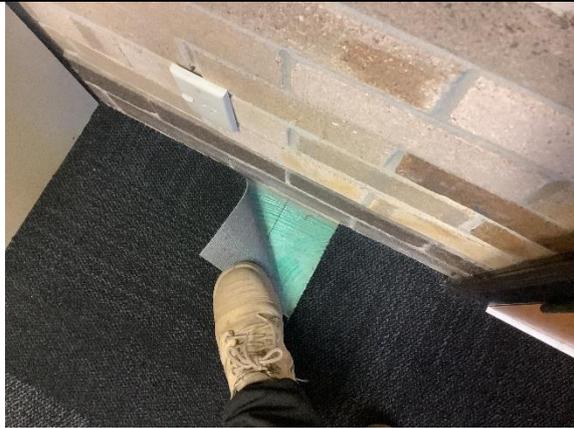
Photo 97: Building G – G.G.13 – Throughout – Floor Covering – Vinyl Tiles - Green

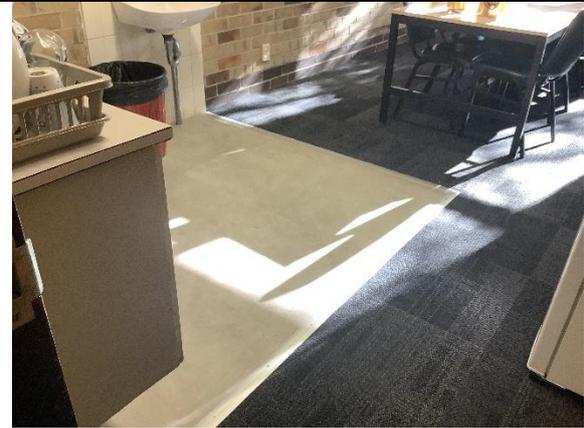
Photo 98: Building G – Entrance – Floor Covering – Vinyl Tiles - Green

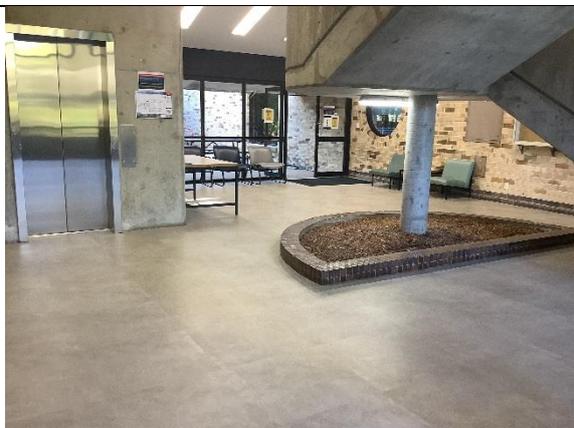
Photo 101: Building G – G.G.1,2,3,18 – Throughout – Floor Covering – Vinyl Tiles - Grey

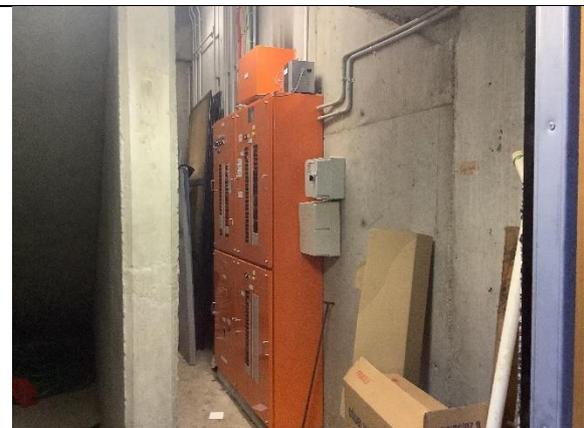
Photo 102: Building G – G.G.33 – Electrical Distribution Board – Electrical Components

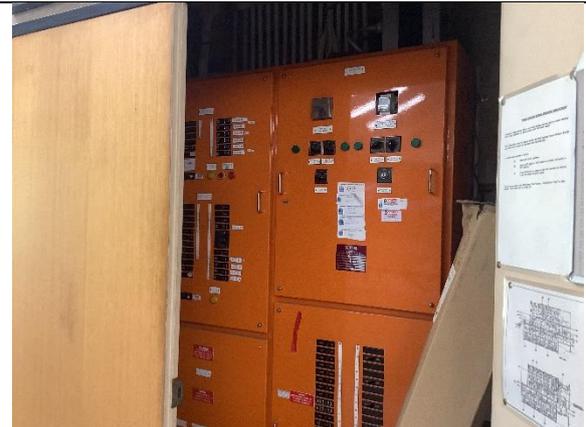
Photo 106: Building G – G.1.25 – Electrical Distribution Board – Compressed Bituminous Electrical Panel

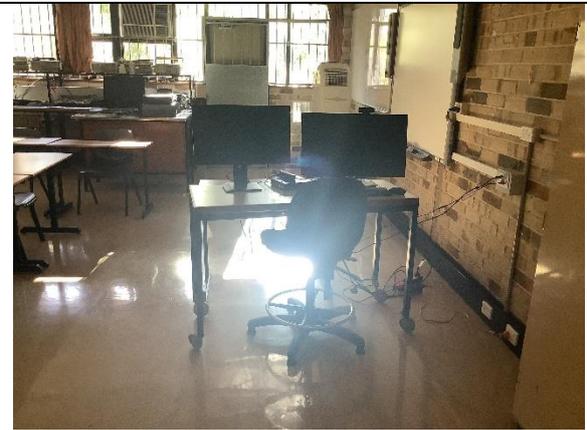
Photo 110: Building G – G.1.29 – Throughout – Floor Covering – Vinyl Tiles - Grey

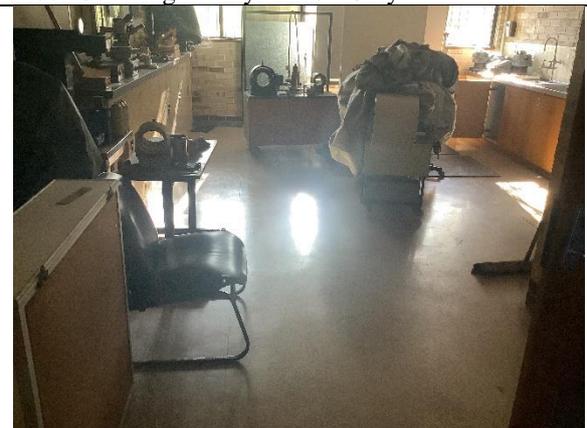
Photo 112: Building G – G.1.4 – Throughout – Floor Covering – Vinyl Tiles - Grey

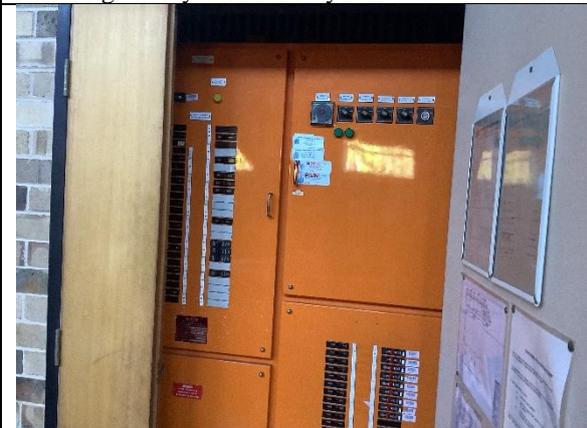
Photo 113: Building G – G.1.31 – Electrical Distribution Board – Compressed Bituminous Electrical Panel

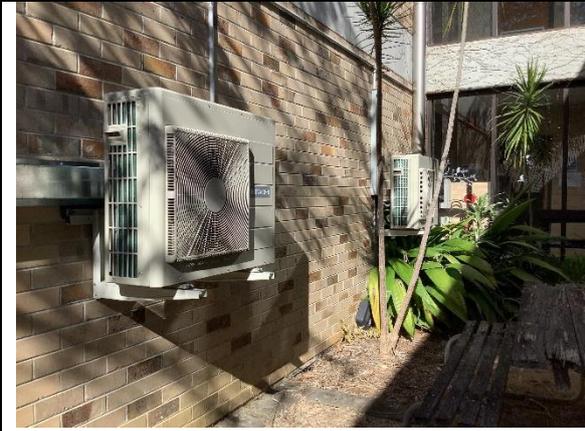
Photo 115: Building H – Throughout – A/C Units

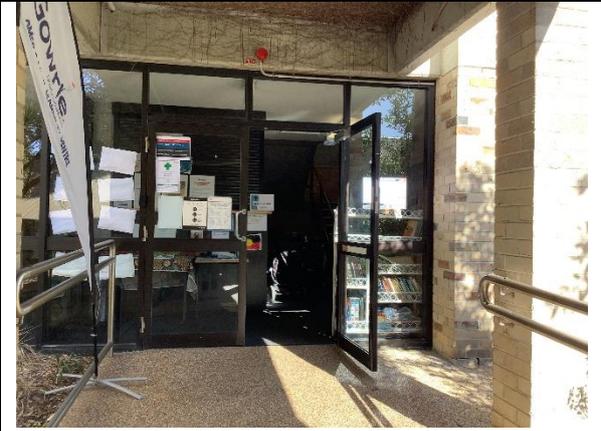
Photo 116: Building H – Throughout – Door Frames

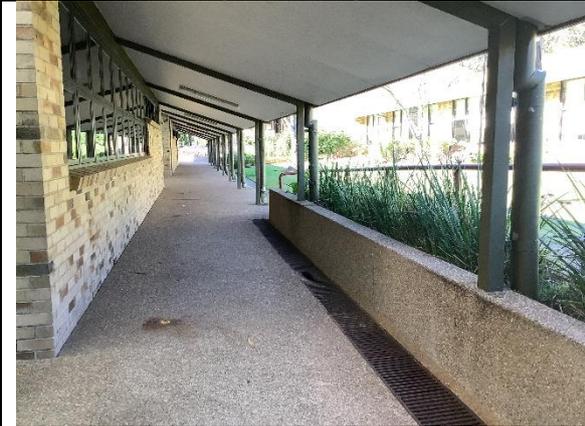
Photo 117: Building H – H.1.19 – Throughout – Awning – Fibre Cement Sheet

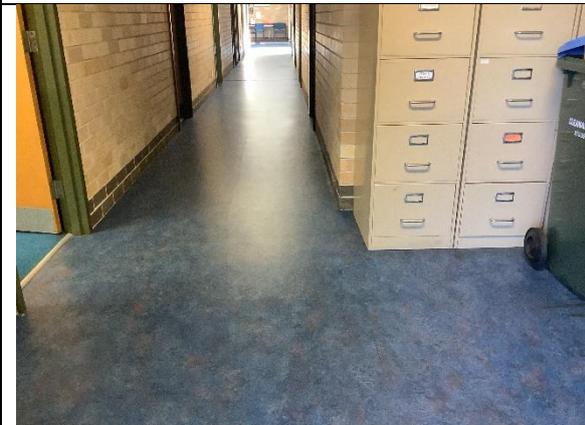
Photo 119: Building H – H.G.6 – Throughout – Floor Covering – Vinyl Tiles – Blue

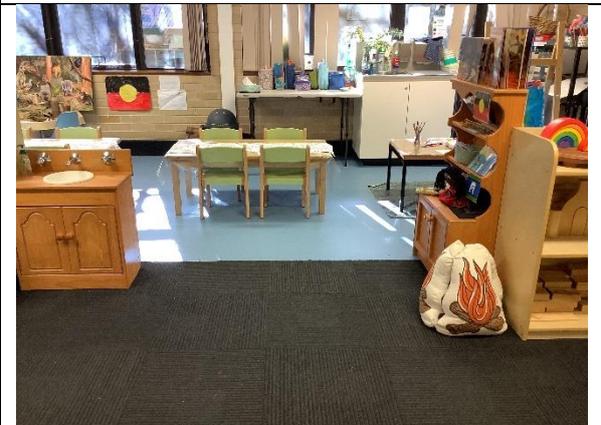
Photo 120: Building H – H.G.3,4 – Throughout – Floor Covering – Vinyl Sheet - Blue

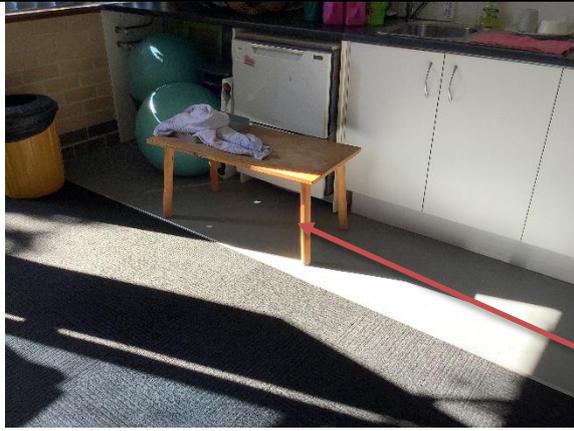
Photo 121: Building H – H.G.7 – Throughout – Floor Covering – Vinyl Sheet - Blue

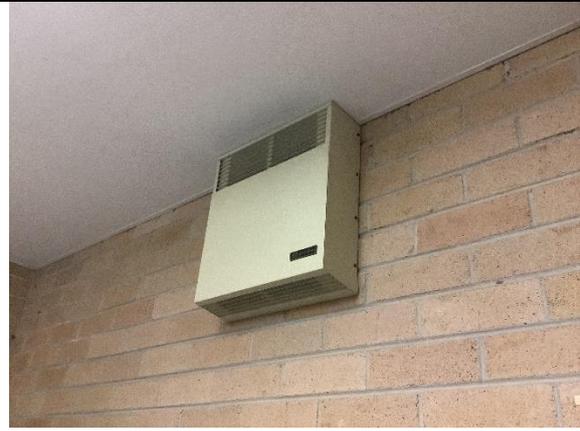
Photo 122: Building H – H.G.13,14,17 – Various Throughout – Walls – Heater – Internal Components

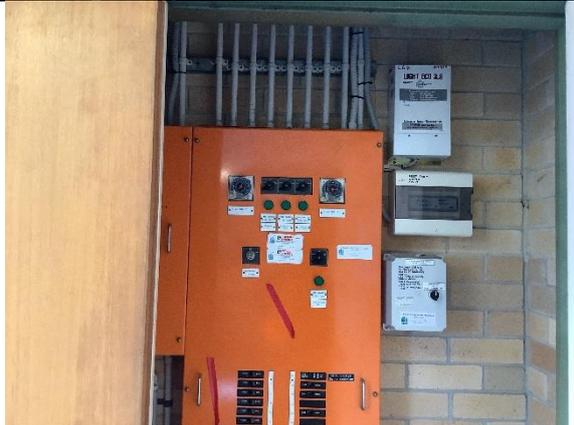
Photo 123: Building H - H.1.15 – Electrical Distribution Board – Compressed Bituminous Electrical Panel

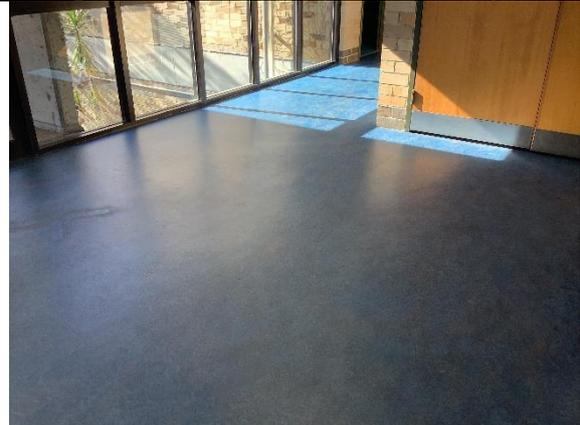
Photo 124: Building H – H.1.5 – Throughout – Floor Covering – Vinyl Tiles - Blue

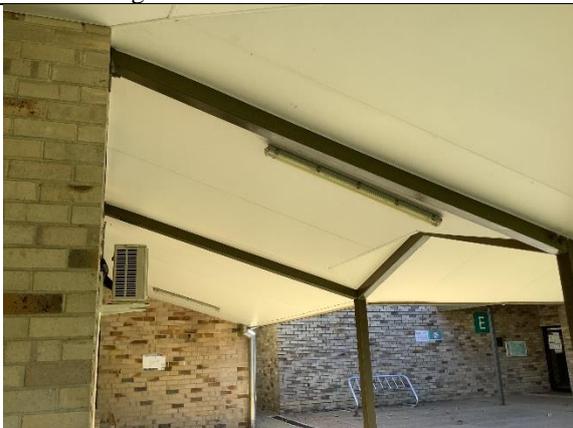
Photo 131: Building J – J.G.46 – Throughout –
Awning – Fibre Cement Sheet

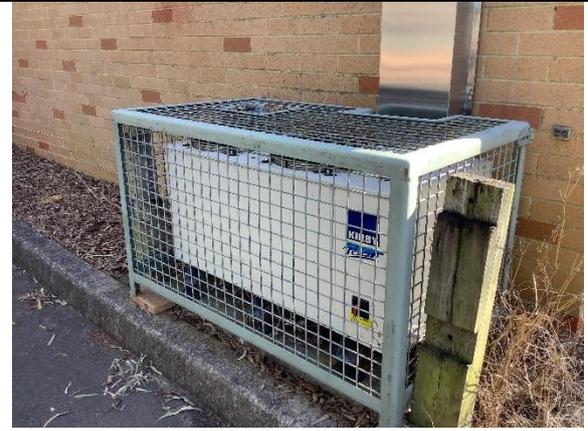
Photo 134: Building K – Various – Throughout – A/C Units

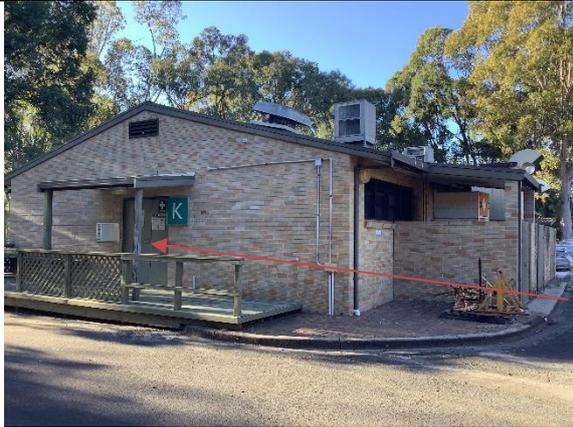
Photo 135: Building K – Throughout – Paint - Green

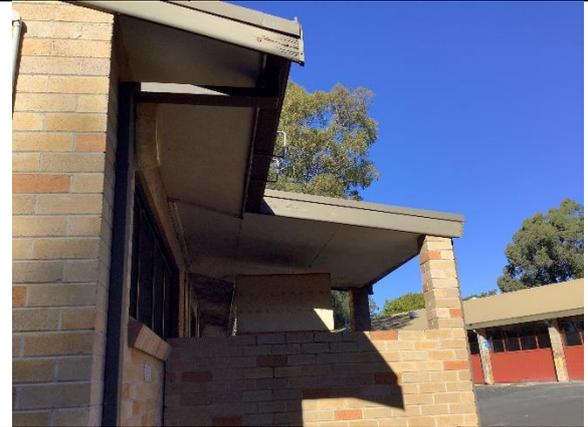
Photo 136: Building K – K.G.6 – Throughout – Awning – Fibre Cement Sheet

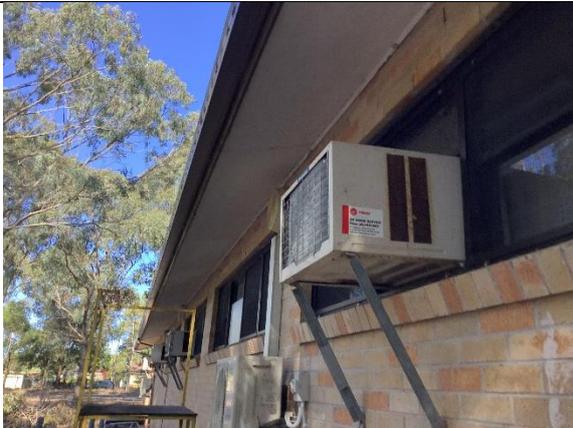
Photo 137: Building K – Various – Throughout – Awning – Fibre Cement Sheet

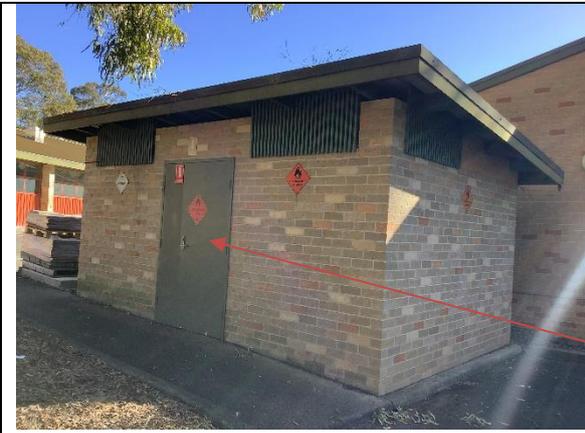
Photo 139: Building L – Doors – Paint - Green

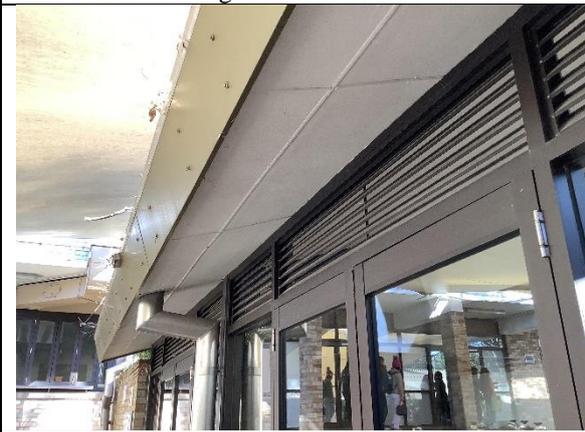
Photo 141: Building M – Various – Throughout – Awning – Fibre Cement Sheet

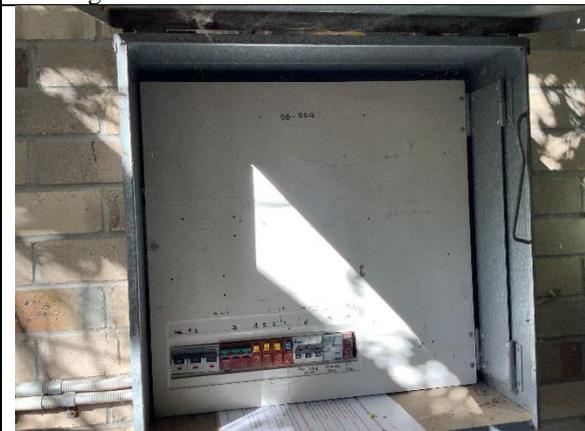
Photo 143: Building M – West – Electrical Distribution Board – Plastic Electrical Board

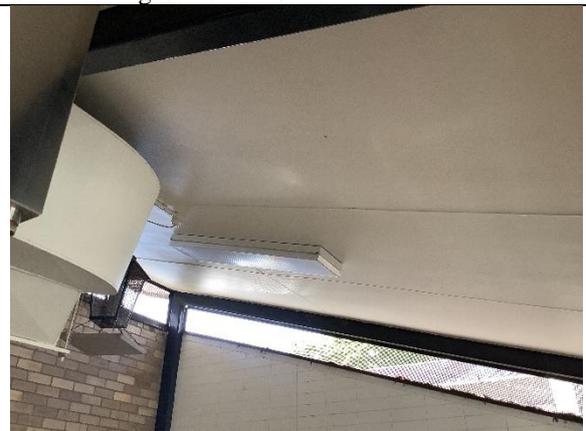
Photo 144: Building M – M.G.1 – Throughout – Ceiling Lining – Fibre Cement Sheet

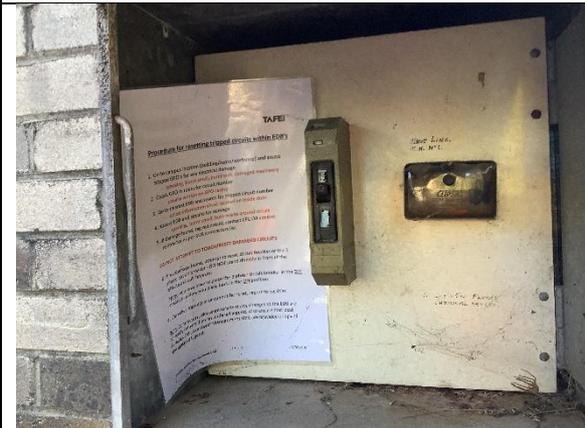
Photo 147: Building N – South – Electrical Distribution Board – Timber Electrical Board

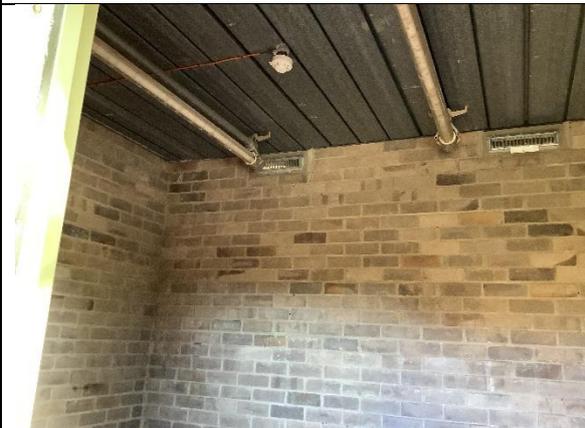
Photo 149: Building N – Various – Throughout – Light Fittings – Internal Components
