TAFE NSW

HAZARDOUS MATERIALS RESURVEYS

PADSTOW TAFE CAMPUS
RAINE RD, PADSTOW NSW 2211

DATE OF INSPECTION: 13-15 JUNE 2023

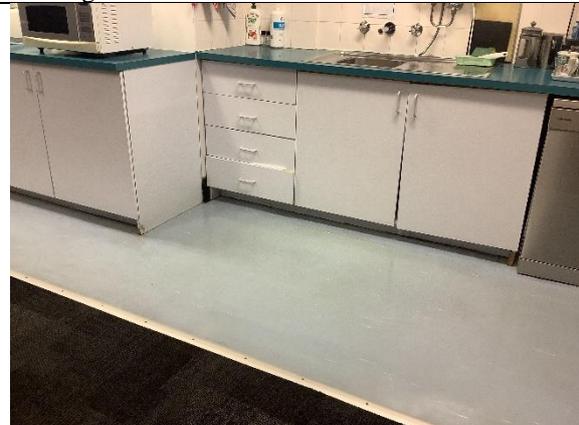
Photo 23: Building B – B.G.7 – Throughout – Floor Covering – Vinyl Sheet - Blue

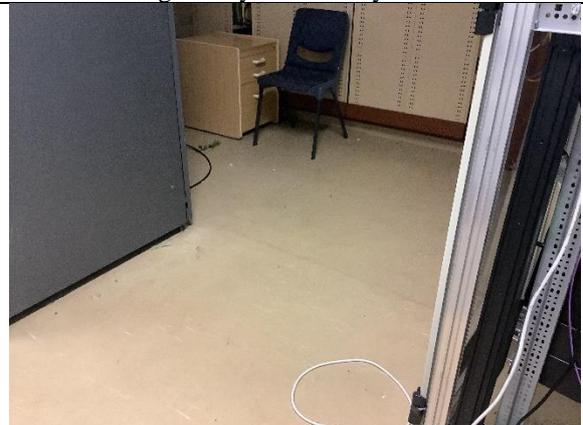
Photo 24: Building B – B.G.12 – Throughout – Floor Covering – Vinyl Sheet - Brown

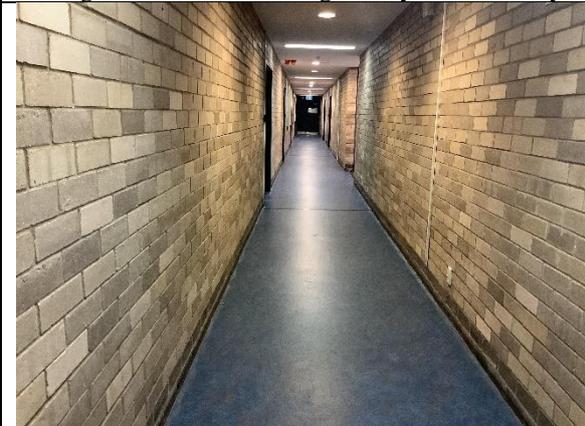
Photo 39: Building C – C.G.19 – Throughout – Floor Covering – Vinyl Sheet – Hessian Backed - Blue

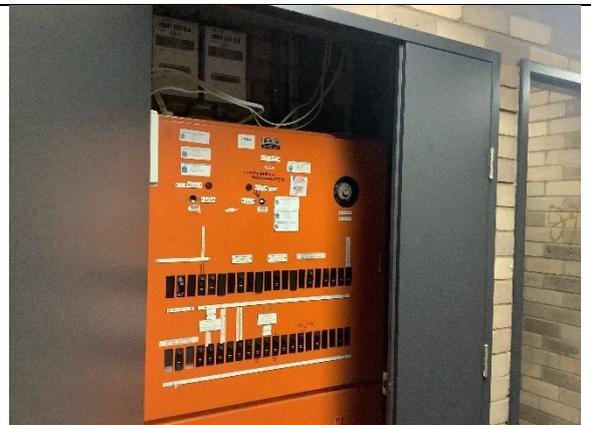
Photo 42: Building C – C.1.13 – Electrical Distribution Board – Compressed Bituminous Electrical Panel

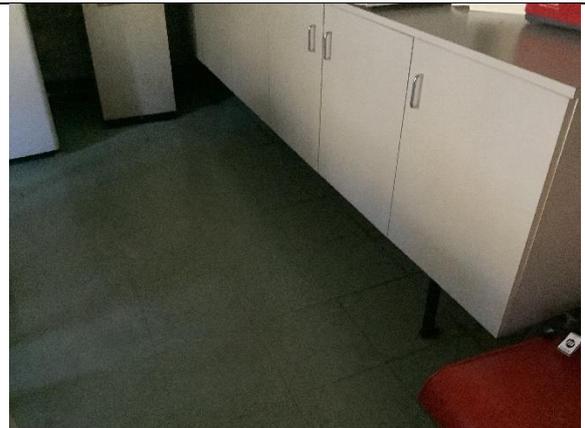
Photo 52: Building D – D.G.16 – Throughout – Floor Covering – Vinyl Tiles - Green

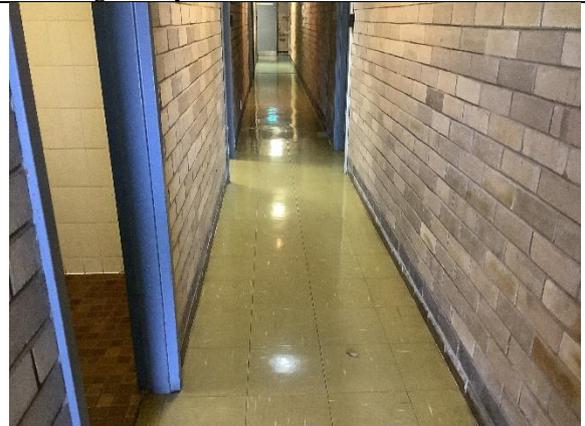
Photo 54: Building D – D.G.25 – Throughout – Floor Covering – Vinyl Tiles - Khaki

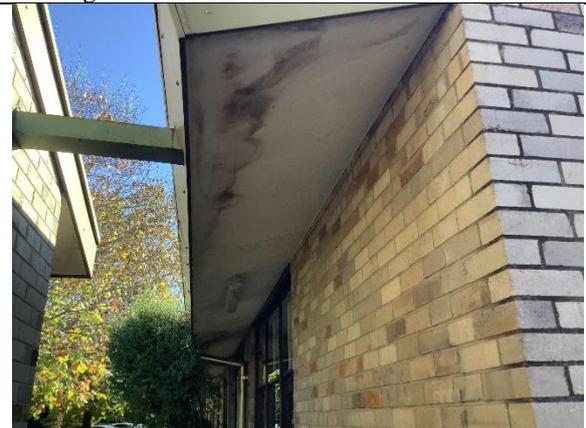
Photo 64: Building E – E.G.6 – Throughout Awning – Fibre Cement Sheet

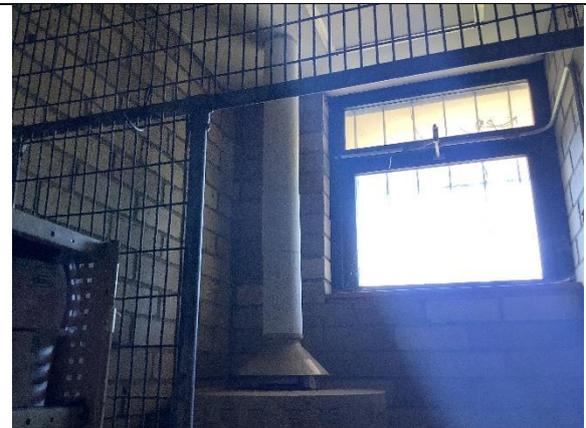
Photo 66: Building E – E.G.10 – North – Flue – Moulded Cement Flue

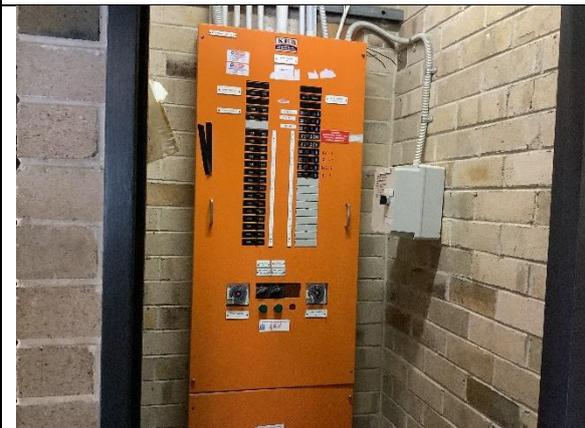
Photo 69: Building E – E.G.28 – Electrical Distribution Board – Compressed Bituminous Electrical Panel

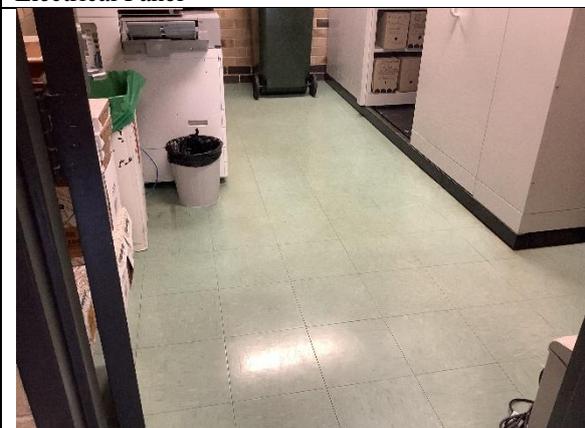
Photo 71: Building E – E.G.19 – Throughout – Floor Covering – Vinyl Tiles – Green

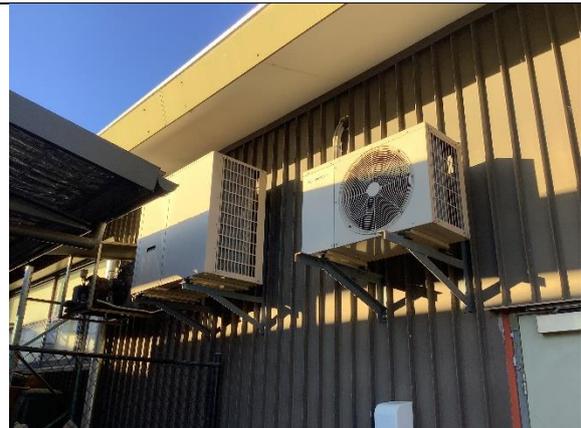
Photo 76: Building F – Throughout – A/C Units

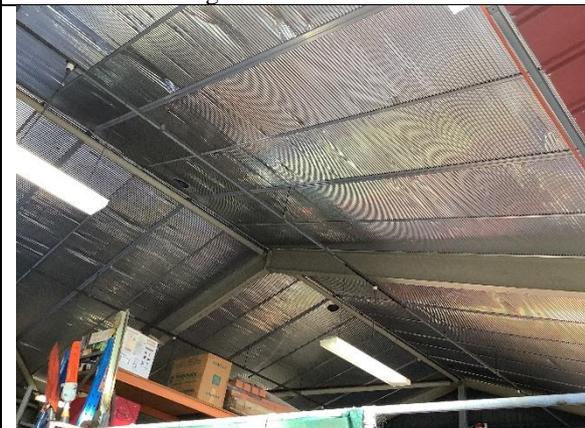
Photo 77: Building F – Throughout – SMF insulation

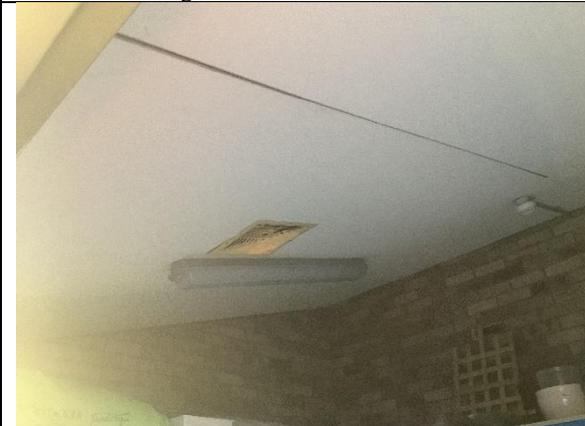
Photo 83: Building F – F.G.4 – Throughout - Ceiling – Fibre Cement Sheet

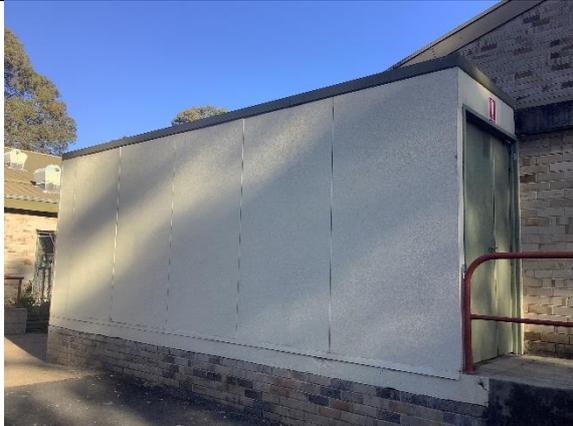
Photo 95: Building G – G.G.53 - Central Partition Wall – Fibre Cement Sheet

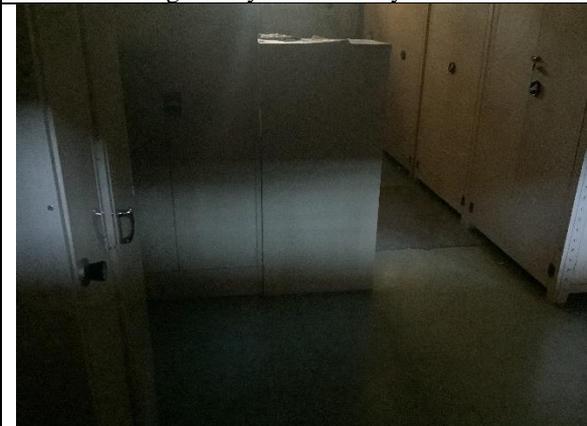
Photo 111: Building G – G.1.3 – Throughout – Floor Covering – Vinyl Tiles - Grey

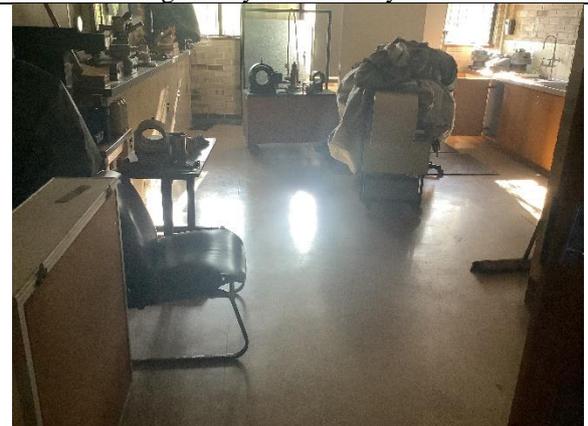
Photo 112: Building G – G.1.4 – Throughout – Floor Covering – Vinyl Tiles - Grey

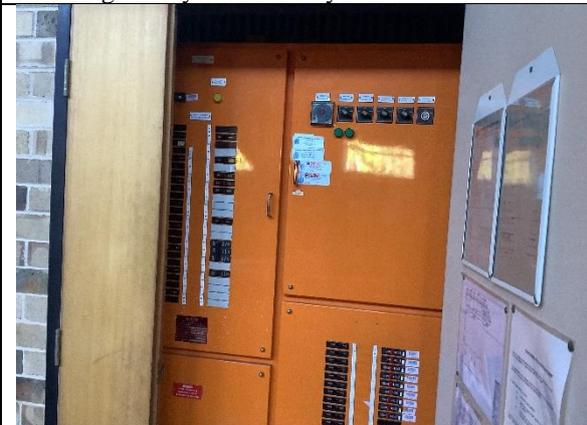
Photo 113: Building G – G.1.31 – Electrical Distribution Board – Compressed Bituminous Electrical Panel

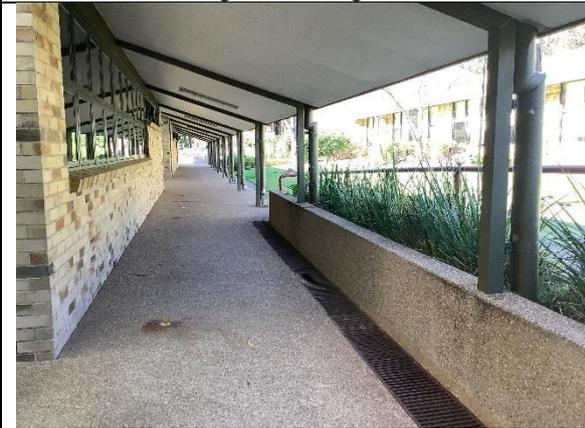
Photo 117: Building H – H.1.19 – Throughout – Awning – Fibre Cement Sheet

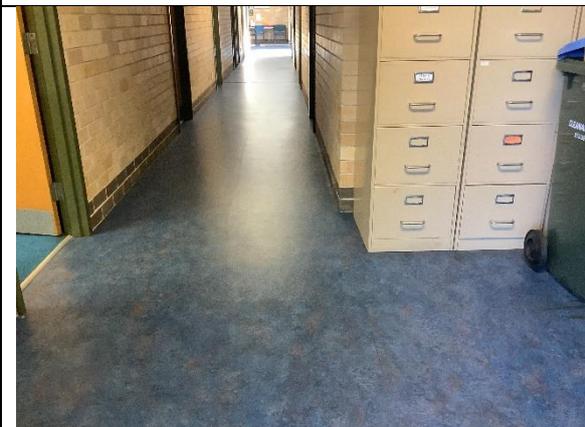
Photo 119: Building H – H.G.6 – Throughout – Floor Covering – Vinyl Tiles – Blue

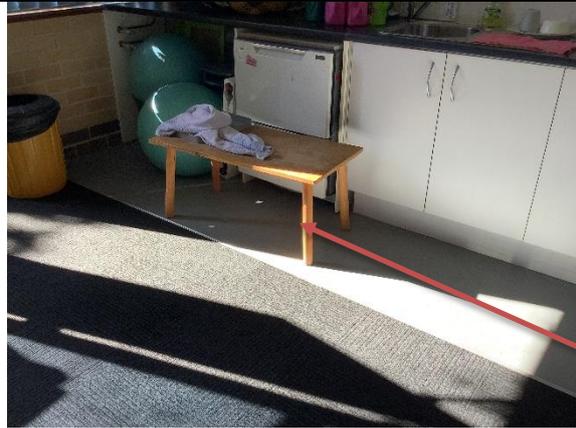
Photo 121: Building H – H.G.7 – Throughout – Floor Covering – Vinyl Sheet - Blue

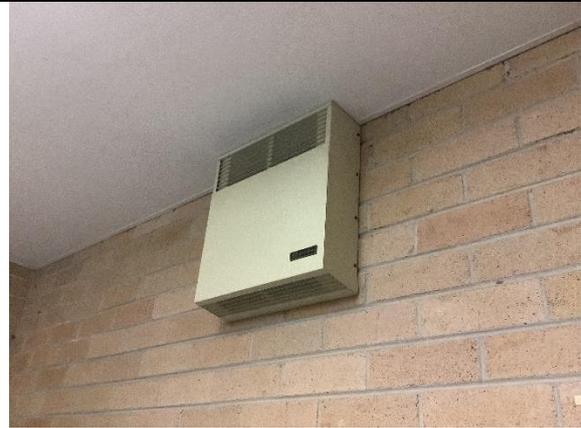
Photo 122: Building H – H.G.13,14,17 – Various Throughout – Walls – Heater – Internal Components

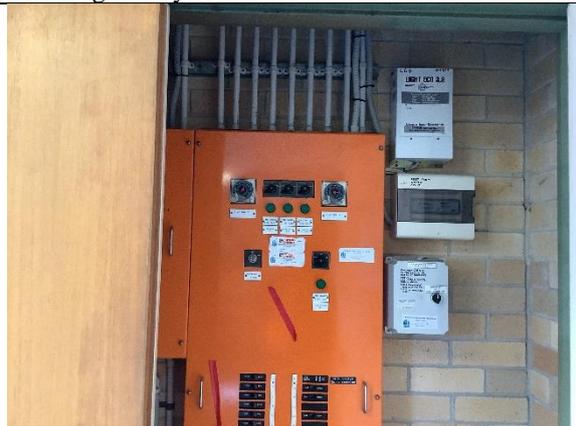
Photo 123: Building H - H.1.15 – Electrical Distribution Board – Compressed Bituminous Electrical Panel

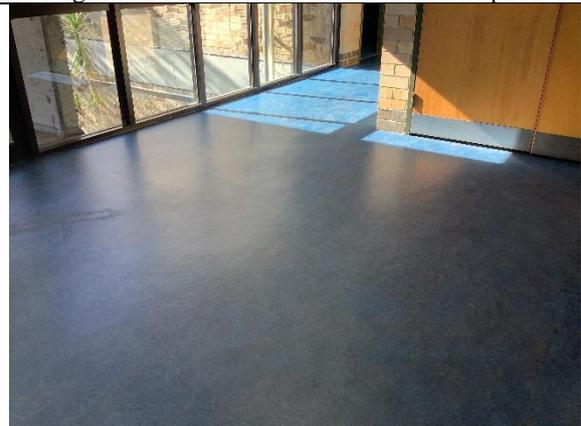
Photo 124: Building H – H.1.5 – Throughout – Floor Covering – Vinyl Tiles - Blue

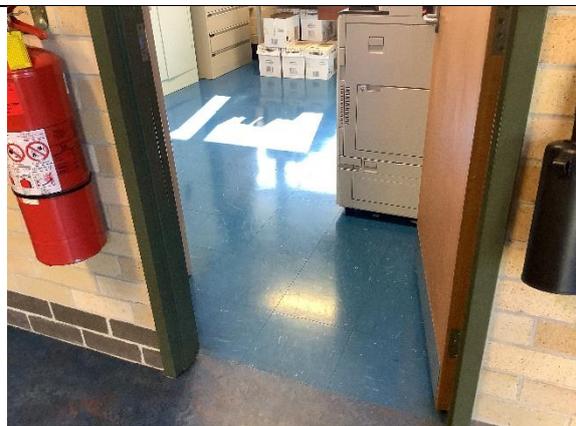
Photo 125: Building H – H.1.6 – Throughout – Floor Covering – Vinyl Tiles - Blue

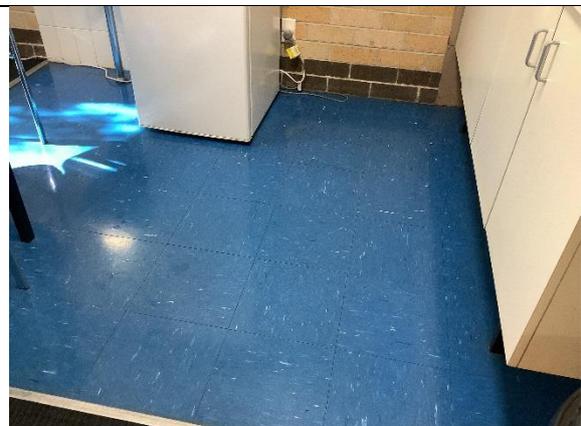
Photo 126: Building H – H.1.7,15,18 – Throughout – Floor Covering – Vinyl Tiles - Blue

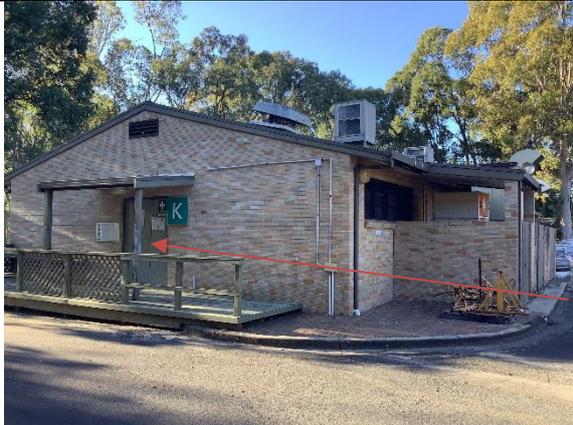
Photo 135: Building K – Throughout – Paint - Green

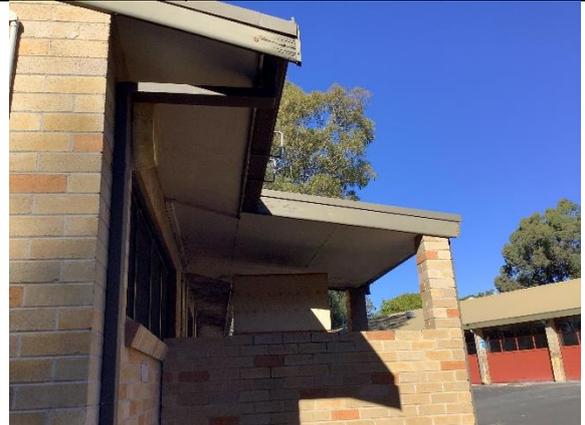
Photo 136: Building K – K.G.6 – Throughout – Awning – Fibre Cement Sheet

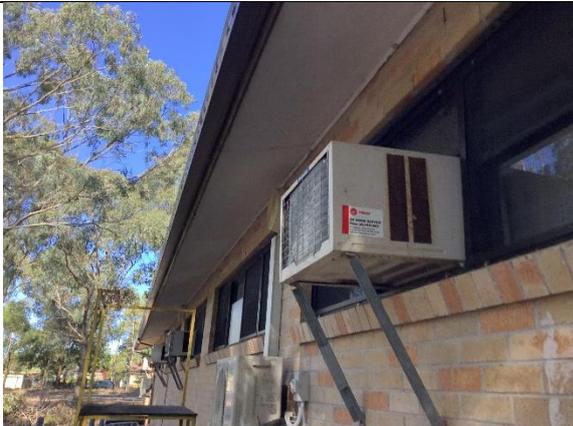
Photo 137: Building K – Various – Throughout – Awning – Fibre Cement Sheet

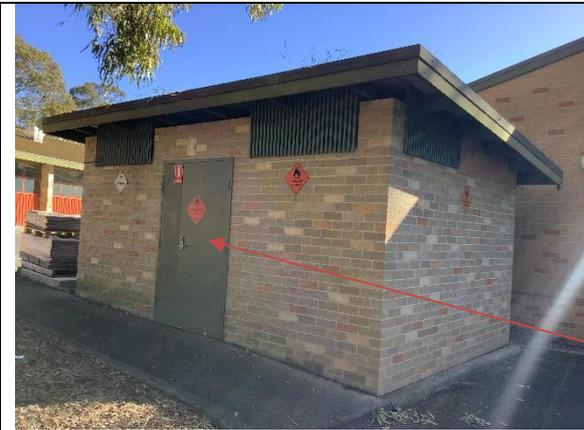
Photo 139: Building L – Doors – Paint - Green

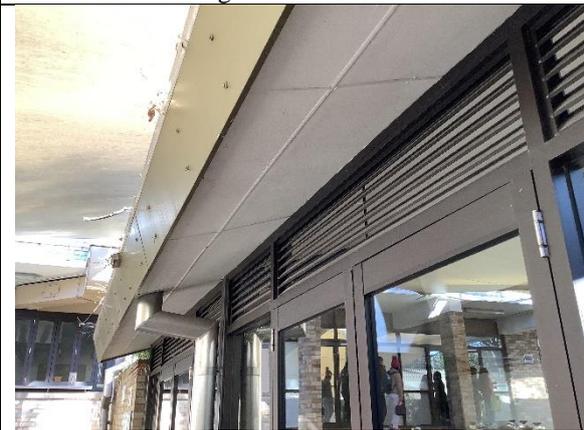
Photo 141: Building M – Various – Throughout – Awning – Fibre Cement Sheet

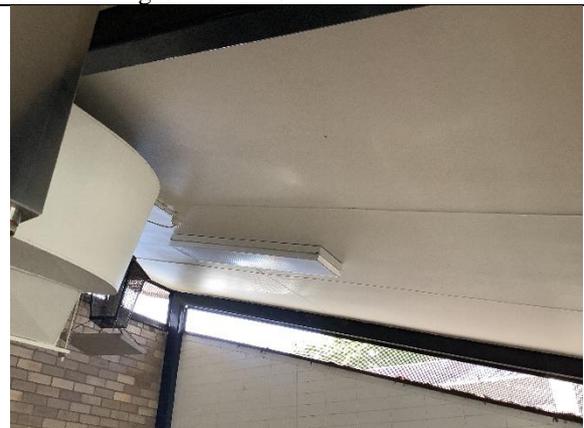
Photo 144: Building M – M.G.1 – Throughout – Ceiling Lining – Fibre Cement Sheet
